PS**THE
PREVENTIVE
MAINTENANCE
MONTHLY**

ISSUE 670 SEPTEMBER 2008

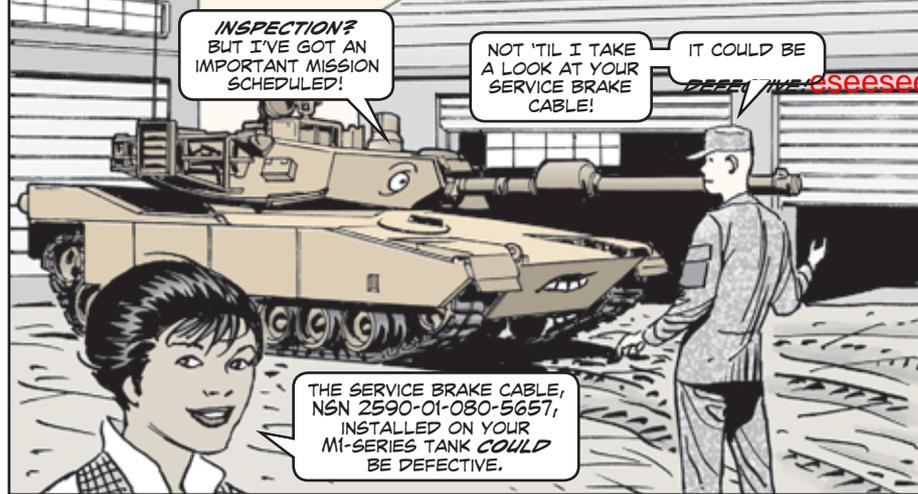
Check the Brake for Goodness Sake!

THE INNER CORE CONDUIT IN THE BAD CABLES DOESN'T HOLD UP TO HIGH TEMPERATURES.

ENGINE HEAT CAN CAUSE THE CONDUIT TO MELT.

IF THAT HAPPENS, THE BRAKES MAY NOT RELEASE AFTER THEY'RE ENGAGED AND THE TRANSMISSION COULD BE DAMAGED.

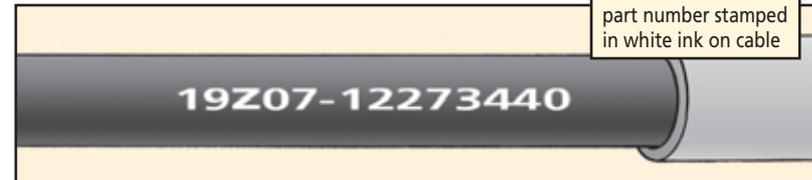
Look for CAGE and part number stamped in white ink on cable

The bad cables will have 19207-12273440 stamped on the cable. Note that the "2" in the 19207 may appear to look like a Z. These cables should be replaced and an SF 368, *Product Quality Deficiency Report*, submitted for credit and disposition instructions.

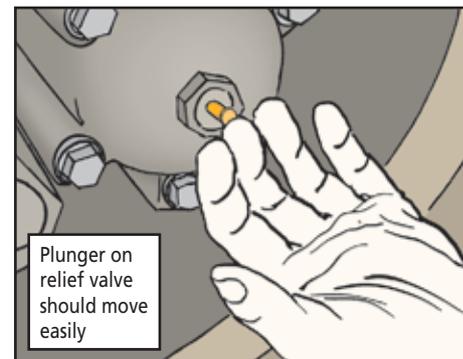
A roadwheel relief valve that's clogged with dirt and sand won't relieve pressure when you pump in new grease. The pressure grows until something gives—usually the hub seal.

When the seal goes, so does the lube. The result is burned-out bearings.

Plunger on relief valve should move easily

If it slides out smoothly and pops back in when you release it, the valve's OK. If it doesn't, replace it with relief valve, NSN 4820-01-070-7670.

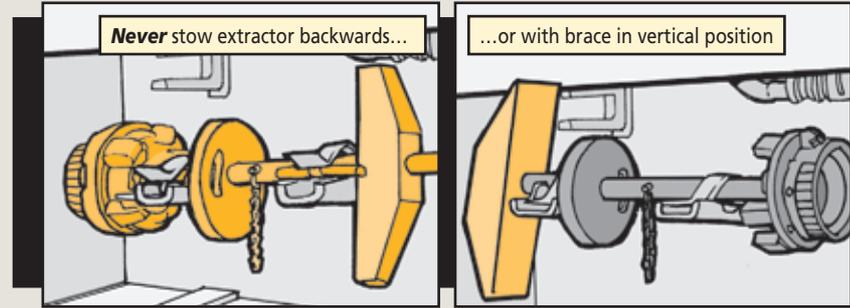
If you store it backwards, or with the brace in the vertical position, the brace bangs into the wiring harness that powers the slip ring contact arms. Banging wears away the harness cover and leads to arcing and electrical failure.

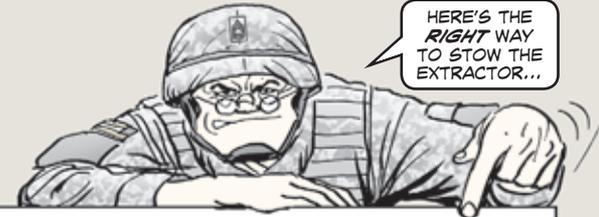
The same problems occur when the brace isn't tightened in place, even if the extractor is stowed properly. Vibration shifts the brace around until it snags the wiring harness.

Slide the brace forward on the extractor shaft until it touches the end of the ratchet handle. Turn the drive nut on the shaft end counter-clockwise until the brace is held firmly against the ratchet handle.

Then, turn the extractor so that the brace is horizontal and facing away from the rear door when it's stored in the cab rack. That way, you avoid harness damage altogether.

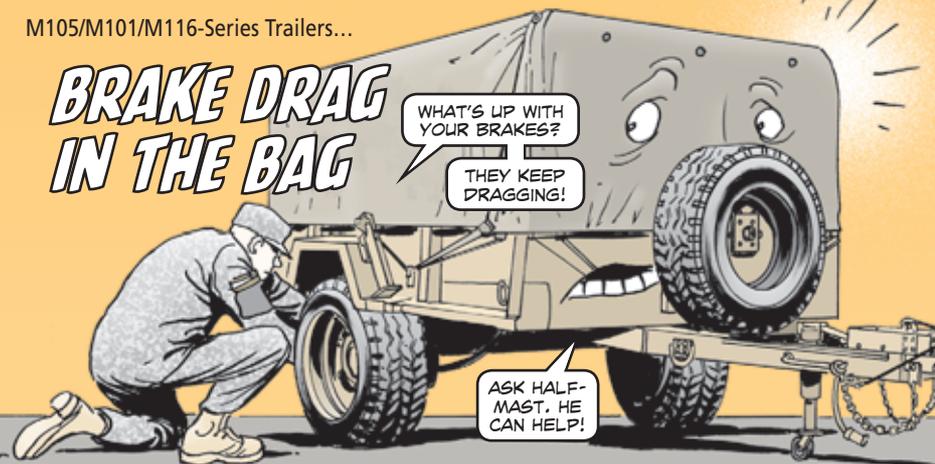
BRAKE DRAG IN THE BAG

Our unit has received M105A3 trailers to replace the -A2 models. But we are having trouble with the brakes dragging while going down the road. We couldn't find a solution in the TM, and have ended up burning up the brakes on several trailers!

The brakes are adjusted, the master cylinder is at 3/4 full, and the parking brake is okay. When brake dragging occurs, we have to crack the bleeders, or loosen the brake line at the rubber hose near the master cylinder to unlock the brakes. What's the best solution?

It's certainly not normal to have brakes drag going down the road! Here's what TACOM LCMC recommends:

1. Start by checking the hand brake system. Make sure the hand brake cable is returning completely. If either side is sticking, replace both of them.
2. Next, check the hand brake handle. Lube it and make sure it functions properly. Fix any problems you find.
3. Finally, inspect the surge brake device. If it's damaged, rusted, or not functioning properly, that may be the culprit behind the brake dragging. There aren't any repair or replacement parts for it, so you'll have to order a new surge brake assembly.

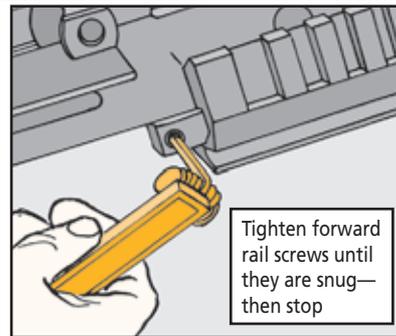
Out-of-round holes are usually caused by your repairman mistakenly thinking the forward rails don't fit. So he enlarges the holes. That makes it impossible to keep the forward rails tight.

If the rails aren't tight, armorers, remove the screws and the forward rails. Check the receiver holes where the forward rails' studs go. If the holes are out-of-round, the M249 needs to be turned in because you will never be able to securely mount the forward rails to the receiver.

If the studs don't fit into the holes easily, your repairman should use a rubber mallet to tap the forward rails into place. That should do the trick. Enlarging the holes accomplishes nothing but ruining the receiver.
