HMMWV...

# An Unsticky Situation

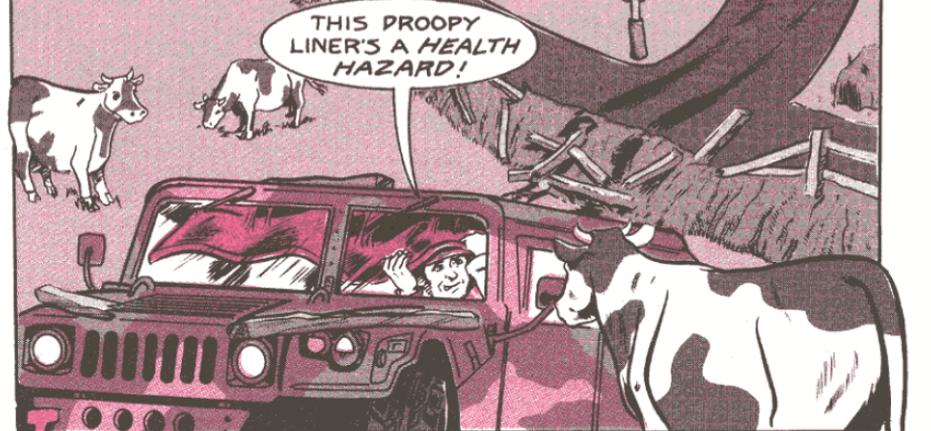
The self-stick backing on the insulation liner in M966, M1025, M1026, M1036, M1045, and M1046 armored carriers doesn't always do its job. It turns loose and lets the headliner droop.

Eyeball the inside roof to see if the liner has any loose spots. Glue it back with primer coating, NSN 8010-01-040-0947. Hold the liner against the roof for about 3 minutes while the primer dries.
