Use Right Mount, Reinforced

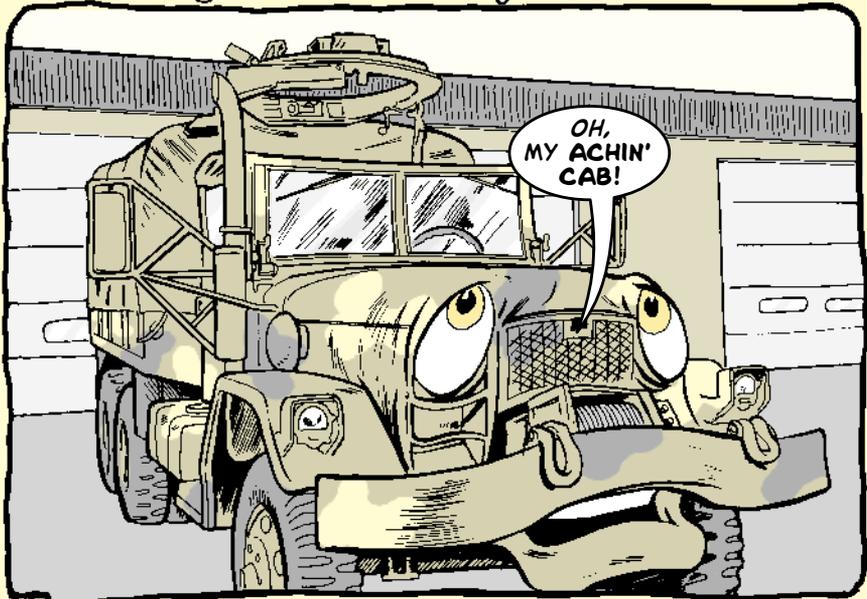
Many of these older trucks still use the obsolete M36 ring mounts that have no reinforcement against vibration. The vibration can cause cab cracks that make your vehicle NMC.

Mount need replacing? Install M66 mount

If you find damage on an M939-series 5-ton, get with your support to fix the damage and install the M66 ring mount, NSN 1005-00-701-2810, with mounting kit, NSN 1005-01-432-3339, and cab reinforcement kit, NSN 2590-01-436-9144.

For the M44-series 2½-ton and M809-series 5-ton trucks, your support will need mounting kit, NSN 1005-01-226-4589, and cab reinforcement kit, NSN 2590-01-322-2694, in addition to the M66 ring mount.
