# Heads Up on Bad Bracket

## Keeping Your Cool

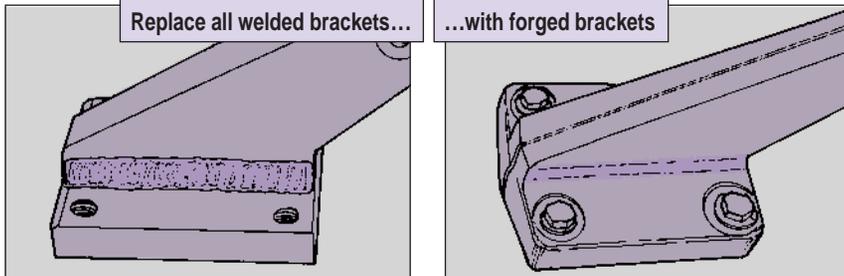
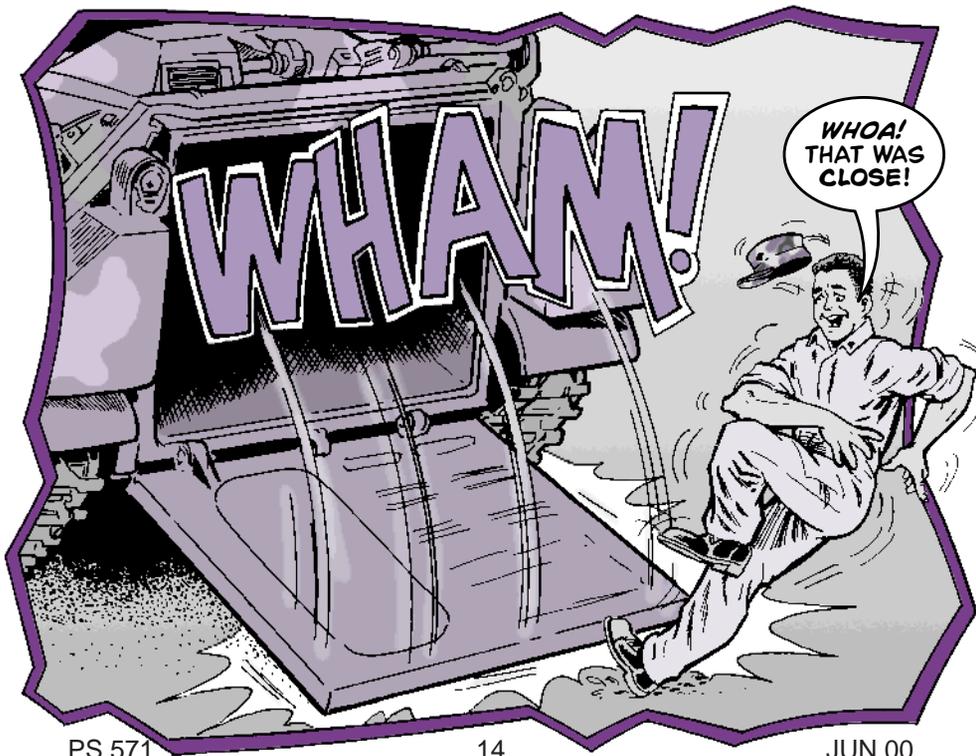
# Bad Bracket

Though covered by only one NSN—3040-01-116-0314—two different ramp brackets are used on the Bradley fleet. One is forged and the other is welded. The welded bracket is defective and could snap.

Check your Bradley—right now—to see which bracket is installed. If your vehicle has the welded bracket, secure the ramp in place with towing cables until you get the brackets replaced.

Follow the procedure in Para 8-7 of TM 9-2350-252-BD, Para 8-6 of TM 9-2350-284-BD, or TACOM Ground Precautionary Message 00-001 to secure the ramp. Once properly secured, you can still access the troop compartment through the ramp access door.

Don't try to order a replacement bracket through the supply system. Instead, contact Faye Gorecki at DSN 786-8257 or (810) 574-8257 or send an e-mail to: [goreckif@tacom.army.mil](mailto:goreckif@tacom.army.mil)

Provide the serial number of each vehicle with a welded bracket and a forged bracket will be forwarded by overnight express.

Mechanics, when replacing the welded bracket, reuse all of the hardware except the locknut, NSN 5310-00-959-1488, that attaches the bracket to the connecting link. A new locknut will come with the forged bracket.

Return the welded bracket in the postage paid package that comes with the forged bracket.

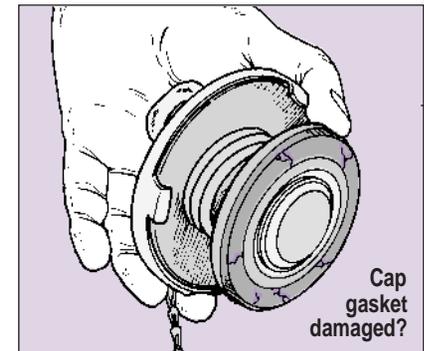
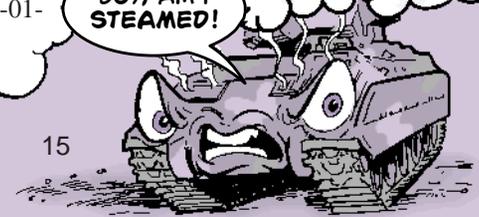
Ordinary use from opening and closing the cap wears down the rubber gasket inside. When the gasket wears enough, the cooling system can't pressurize properly, coolant escapes, and the vehicle overheats.

So, eyeball the gasket for cuts, tears (or unusual wear). Then report a bad radiator cap to your mechanic. He'll order a new one with NSN 5342-01-398-2835.
