Replace CTIS Air Valve Nipple

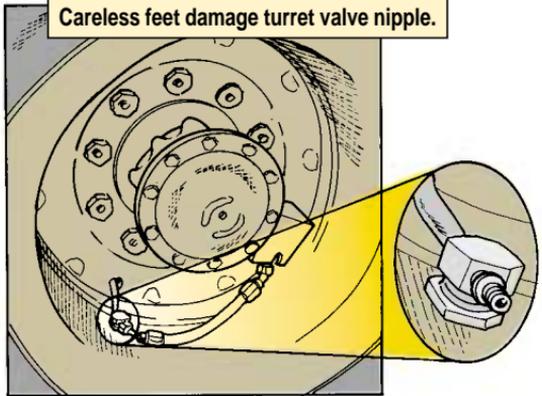
One of the items most often broken in the central tire inflation system on M939A2-series trucks is the nipple on the wheel inflation turret valve.

That's because it's right out in the open where soldiers put their big feet when they climb on board from the side.

Careless feet damage turret valve nipple.

In the past, it was \$12+ to replace the turret valve because the nipple wasn't available as a repair part. Now you can save at least \$10 by ordering the nipple—called a pneumatic tank valve, NSN 4820-01-119-8862.

Now that you've saved some money, help save yourself some repair time by convincing soldiers to climb in from the rear of the truck using the tailgate.
