Tailgate strike plate rivets have been troublemakers on some FMTVs since the trucks were fielded.

M35A3 Wheel Torque Talk

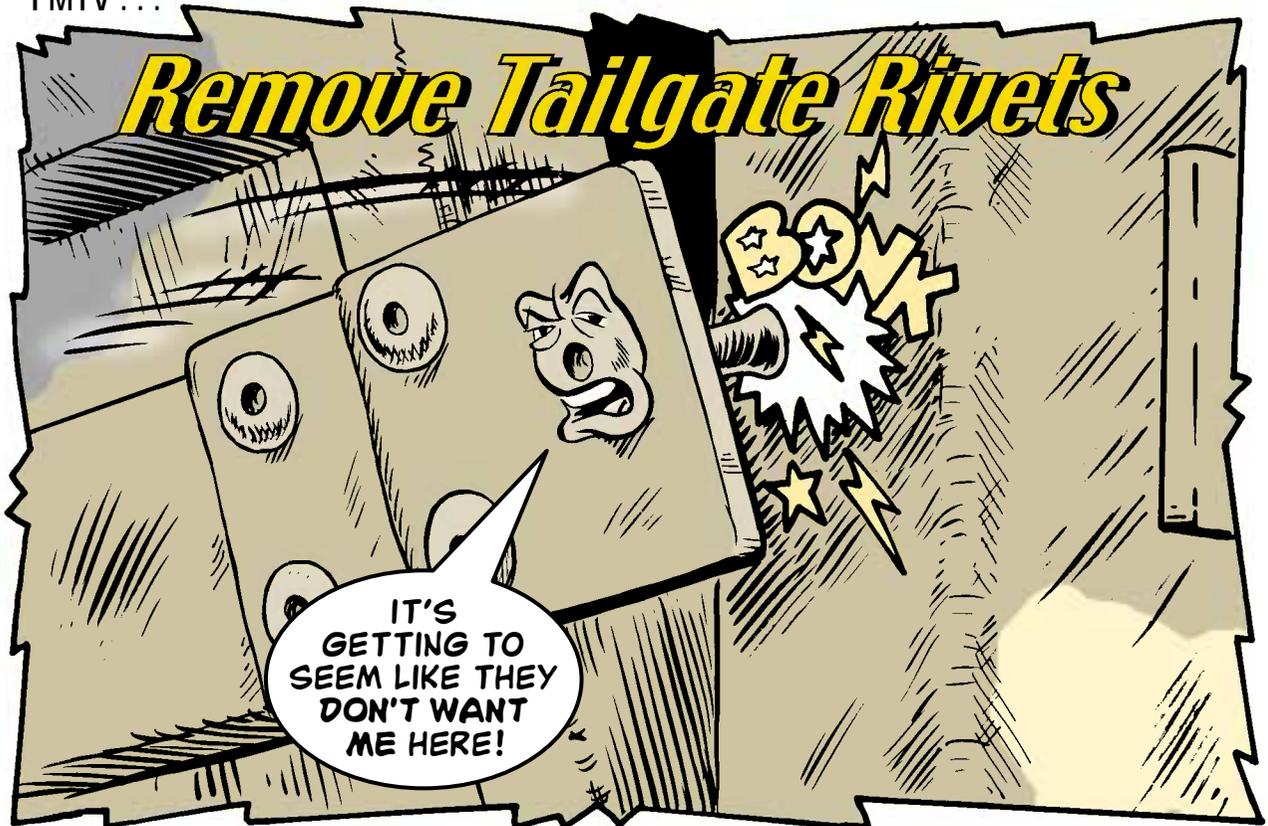
The rivets can keep the tailgate from closing and latching easily—or at all—by butting against the rear canvas bow.

Solve the problem by simply removing the single, stand-alone rivet on each strike plate. Once the rivets are gone, the tailgate should close tighter and latch and lock easier.

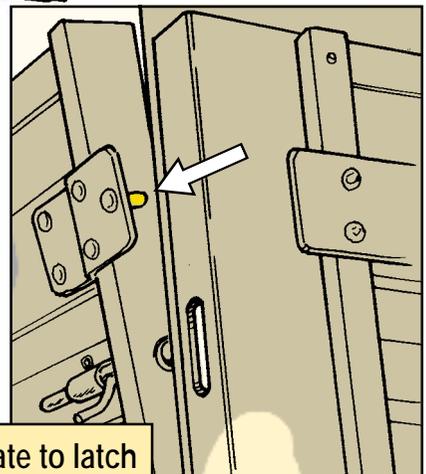
Remove rivet to allow tailgate to latch
