Quick SLO Solutions

Mechanics, if you can't get the suspension lockout (SLO) system working on an MLRS, your first stop should be the troubleshooting procedures in TM 9-1450-646-20-1. The task list on Page 3-9 tells you where to find them.

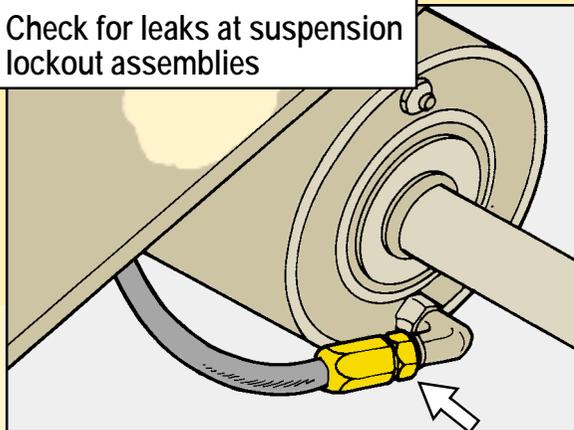
Area 1

The hydraulic lines that attach to the SLO assemblies on the numbers 1, 5 and 6 roadwheel support arms could be leaking.

Check for leaks at suspension lockout assemblies

Get someone to pump the SLO handle while you check each of these

fittings. If you see fluid coming out of any fitting, tighten the connections.

If the leak continues, replace the leaking parts. They're listed in callout E in Fig 28 of TM 9-1450-646-24P.

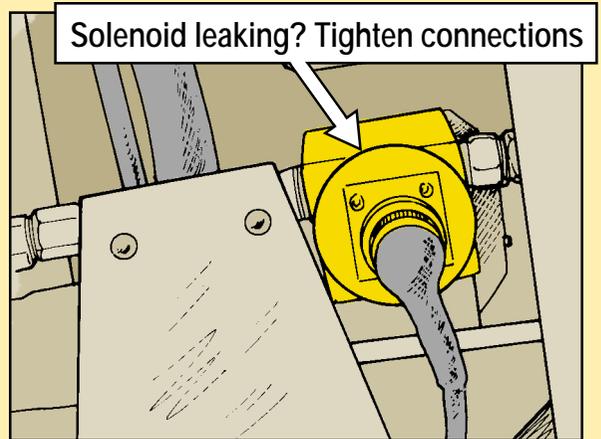
Look for a leaking connection at the solenoid valve, NSN 4810-01-108-5223.

Solenoid leaking? Tighten connections

A leak can limit the pressure at the valve. Without enough pressure to force fluid through the solenoid, the system won't lock the roadwheel support arms. Make sure the connections are all tight.
