Silence Is the Best Sound

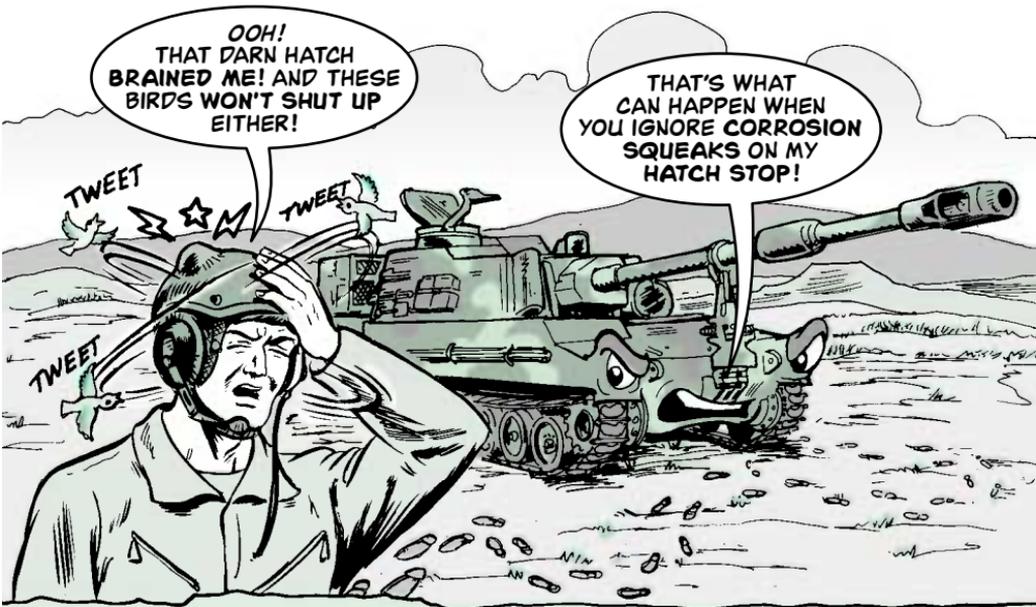
If that's the sound the driver's hatch stop makes on your M109A6 Paladin, then you've got a corrosion problem.

On some older Paladins, the shoulder pin inside the hatch stop is made of carbon steel. It corrodes easily, making it hard to lock open the hatch.

If the hatch isn't properly secured, you'll also be hearing bells—right after the hatch swings closed on your head.

Stop **all** the sound effects by lubing the pin monthly with OE/HDO. Just a few drops where the pin attaches to the stop does the trick. Then exercise the stop to spread the oil along the length of the pin.
