Battery Box Cover Blues

Replace Leaky Packing

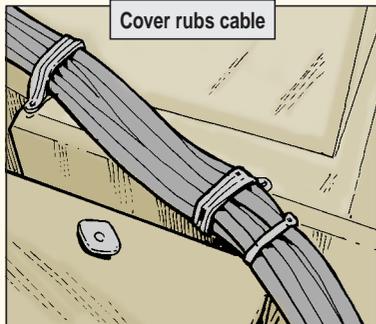
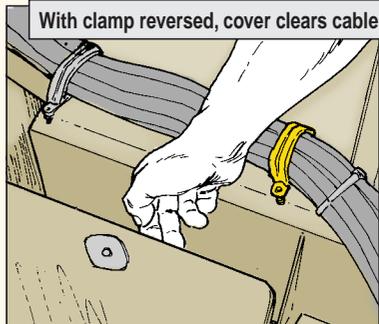
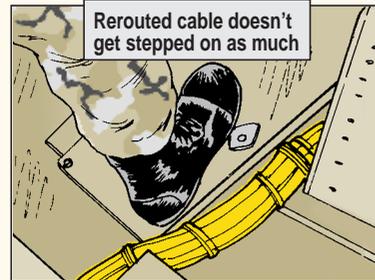
Every time we open the MLRS carrier's battery box cover, the corner rubs against the bundle of cables routed next to the box.

Enough of that rubbing will wear through the insulation on one or more of the cables and short them out.

We stopped this problem by slightly rerouting the bundle of cables. Just remove the cable clamp nearest the battery box lid and reverse it. Doing that puts a slight dogleg in the bundle of cables that allows it to clear the battery box cover.

It also eliminates a second problem: operators accidentally

stepping on the cable when the cab is up. Rerouting the cable gets it up higher and out of the way of those big feet.

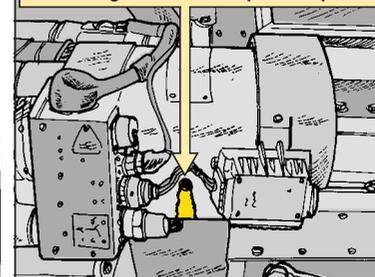
If you see oil coming out of the breather port on your MLRS' generator, don't ignore it. Chances are the generator's preformed packing, NSN 5331-01-010-3371, is leaking.

As the oil oozes out of the breather port, it's spread all over the engine by the fantower. That creates a real fire hazard.

Oil leaking from breather port? Report it

Call in your mechanic and have the packing replaced right away.
