# REPLACE BAD EXHAUST PACKINGS

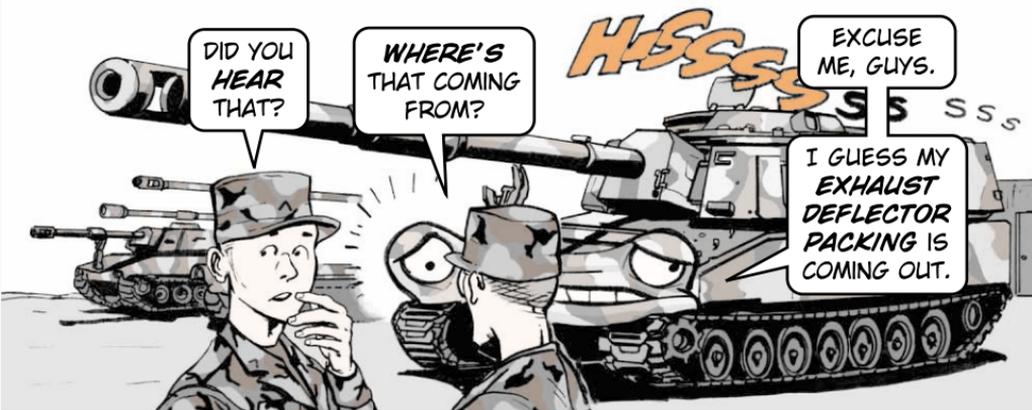
**D**oes your howitzer or ammo carrier have exhaust leaks in the engine compartment?

If so, the culprit could be a worn-out exhaust deflector packing. It's supposed to plug up the space between the deflector and the end of the engine exhaust pipe.

Once the packing is worn enough, you'll be getting exhaust leaks in the engine compartment. That's a definite no-no.

Replace that packing when you start seeing leaks. A new packing comes

with NSN 5330-01-382-4272. Use the whole packing to fill the gap between the deflector and the hull mount.

If the seal support is bent so the deflector won't seat right, replace it. Use NSN 2990-00-894-0075 for a new support.

Make sure the cap screws that hold the deflector snug against the packing are not stripped or cross-threaded. Replace bad screws with NSN 5305-00-269-3238.

If you still can't get a good seal around the exhaust deflector, contact your support—now.
