M1A1 Tank...

# Replace Setscrew Right

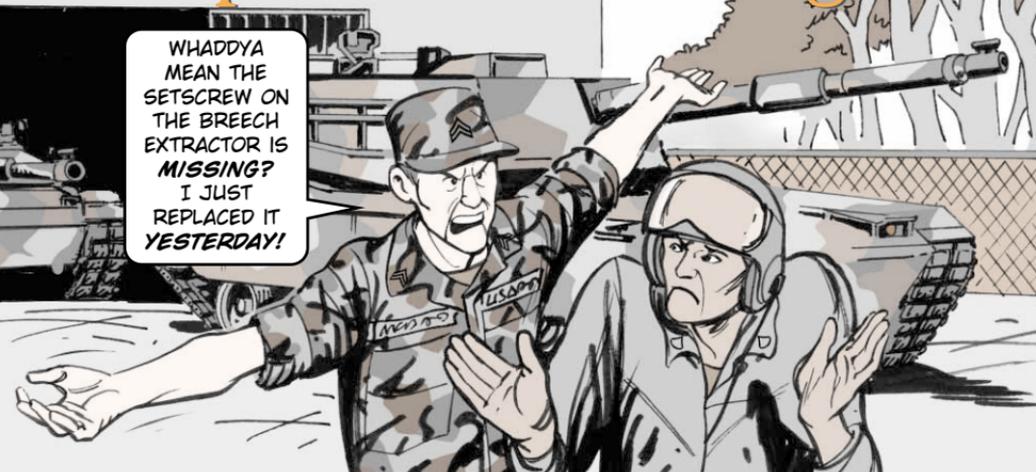
WHADDYA  
MEAN THE  
SETScrew ON  
THE BREECH  
EXTRACTOR IS  
MISSING?  
I JUST  
REPLACED IT  
YESTERDAY!

It's no fun to replace a broken or missing setscrew in the breech mechanism of an M1A1 tank's left extractor—especially if you just did it a few days ago.

First, clean the extractor with dry cleaning solvent, NSN 6850-00-285-8011, and a clean rag, NSN 7920-00-205-1711. Cleaning gets rid of old sealing compound, carbon and grease that can keep the setscrew from bonding tightly to the extractor. Pay special attention to the threads in the setscrew hole.

Next, coat the threads of the new setscrew, NSN 5305-12-189-0277, with sealing compound, NSN 8030-01-025-1692. If you forget the sealing compound, the setscrew will vibrate loose and fall out.

Finally, screw the setscrew in place. Leave  $\frac{3}{4}$  to  $\frac{7}{8}$  inch of the setscrew showing. If the setscrew's too tight, it'll break. But if it's too loose, it'll fall out.
