# Boom Foot Needs Lube

# CLAMP DOWN ON LOOSE HOSE

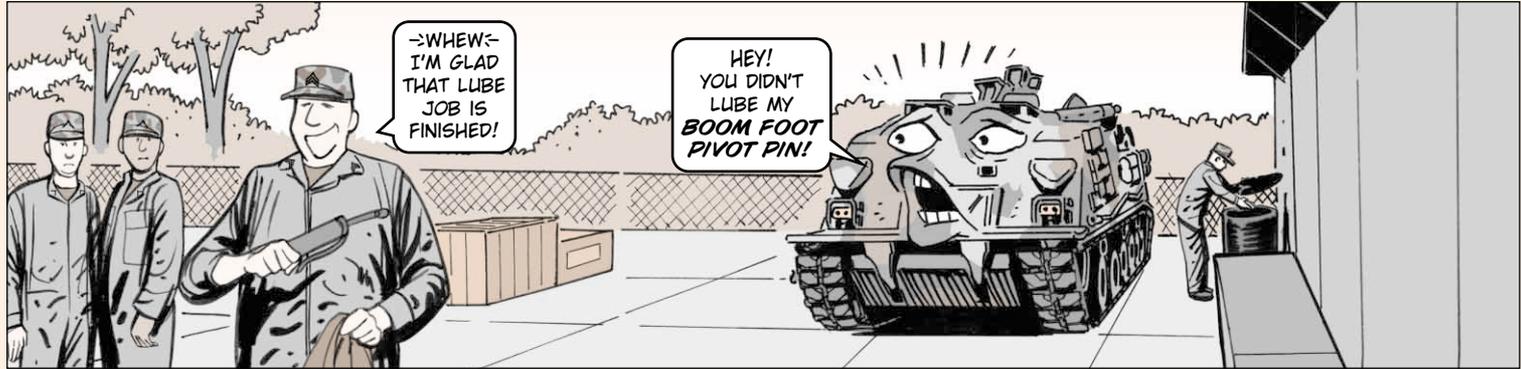
Appendix J in TM 9-2350-256-20 says to lube your M88A1 recovery vehicle's boom foot pivot pins and boom pivot pins quarterly with GAA. But a lot of pins don't get the lube they need.

Eventually, unlubed pins rust to the boom foot. You can tell that's happened when the boom pivot pin rotates as you raise or lower the boom.

If you don't get the pin and trunnion fixed, the trunnion will eventually elongate. The boom is shot until it can be repaired at depot level.

By then it's too late to lube and you'll have to call in DS for help. They'll pull the pin, inspect the hull trunnion and the boom foot for rust, and remove any rust with steel wool.

Once the boom pin is reinstalled, make sure it's locked in place by the retainer. The pin shouldn't slide in or out of the trunnion.

Check the gap between the pin and the trunnion wall, too. A gap of .005 to .025 inch is OK. Anything more and you should have your vehicle inspected for depot overhaul. 'course, you can save yourself this extra work and downtime if you just lube all the boom pins when the TM calls for it.

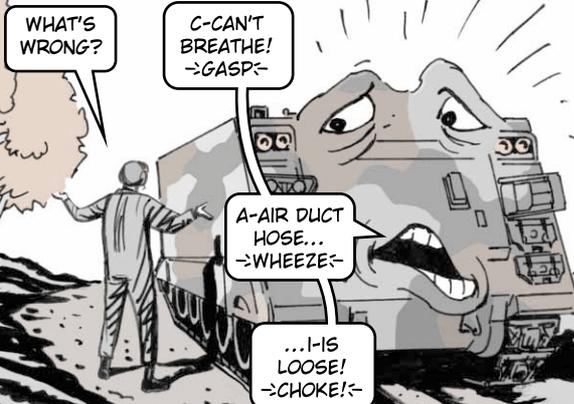
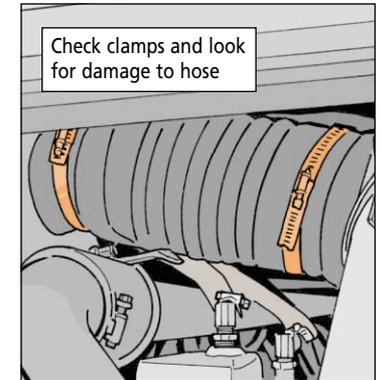
Dirty air is an engine killer for your M113A2 carrier. That's why your crewmen need to keep a close eye on the engine's air duct hose, NSN 4720-01-060-2550.

Vibration loosens the two clamps, NSN 4730-00-908-6294, that hold the duct hose in place. Then dirty, unfiltered air is pulled in past the clamps and the engine is damaged.

Help keep your carrier breathing easy by checking the clamps for tightness before each operation. Eyeball the hose for cuts, tears or other damage. Report any problems to your mechanic.
