TAPE CONNECTOR

FOR A SNUG FIT

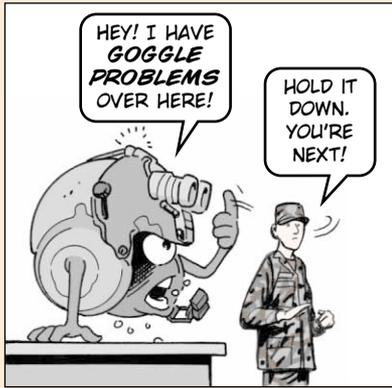
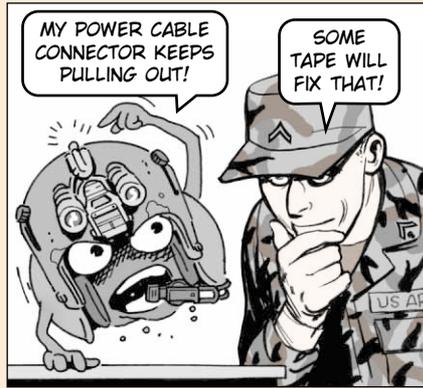
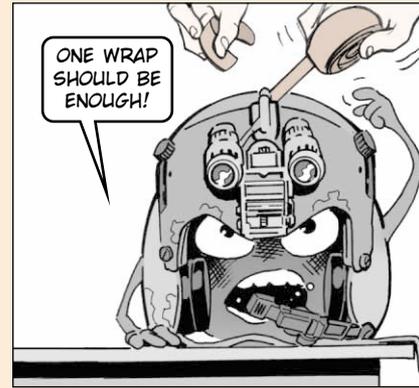
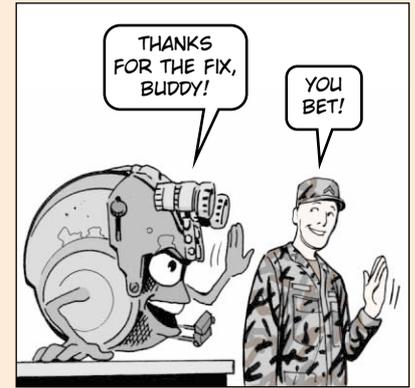
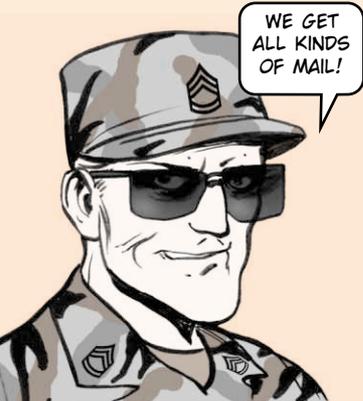
Our pilots have a problem with the AN/AVS-6(V)1/2 night vision goggles' power pack cable. If the fairlead block on the HGU-56/P helmet is worn, the goggle's power cable may not fit snugly into its connector.

The loose fit also creates a second problem. Pilots try to secure the connector by overtightening the access cover screws. That cracks the cover and makes the loose connection looser.

Our ALSE shop has come up with a temporary fix for worn blocks and cracked covers. Until the new blocks, NSN 5340-01-397-0321, come in, we put one wrap of doubled-sided pressure-sensitive tape, NSN 7510-00-634-1549, around the slotted and grooved section of the connector. This shim keeps the connector tight and in place.

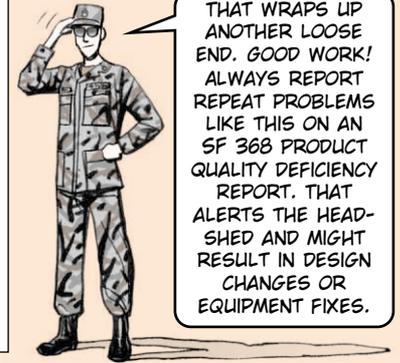
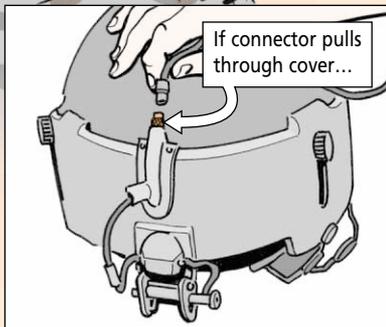
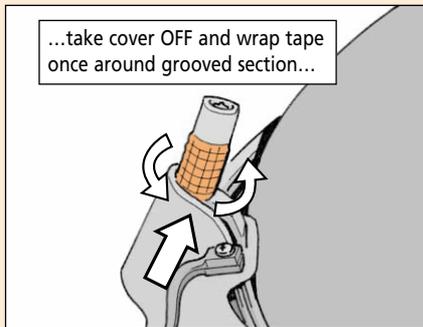
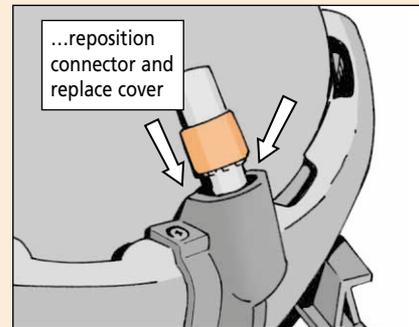
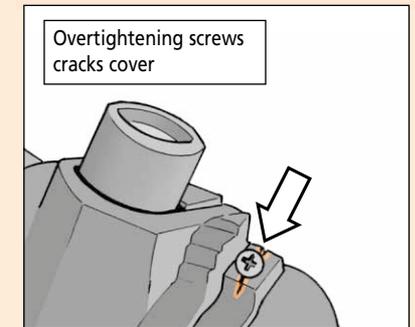
That shaky connection is a safety hazard because it could result in loss of night vision or intermittent operation. That's dangerous.
