# Panel Seal Revisited

## LOCATE THE LEAKY TRANSFER

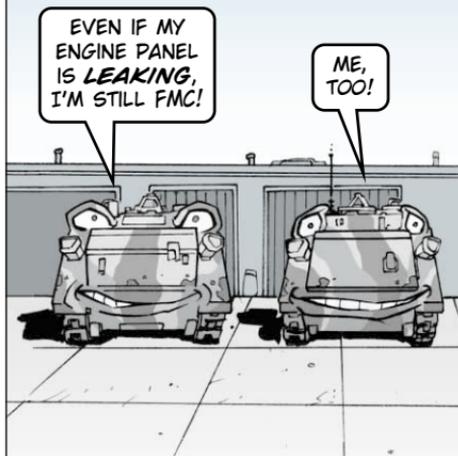
Page 21 of PS 585 said that exhaust fan on the M113A2 family of vehicles blows air **into** the engine compartment. Since that would allow harmful exhaust gases to seep into the crew compartment, the article said vehicles with a leaky engine compartment access panel were NMC.

That's not true. The exhaust fans on both the A2 and A3 family pull air **out** of the engine compartment. Both models remain FMC with failed seals, but you should still replace bad seals as soon as possible to avoid problems with engine cooling.

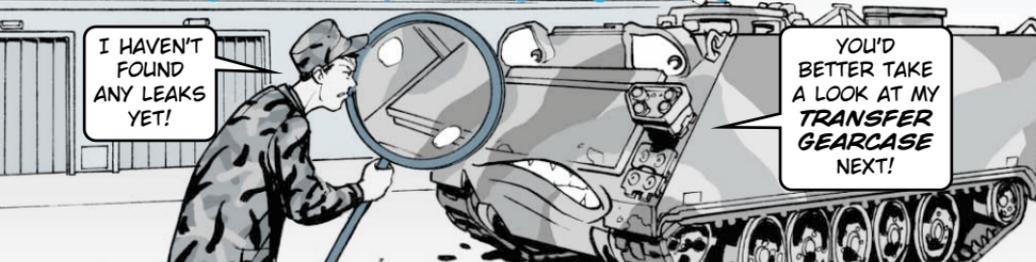
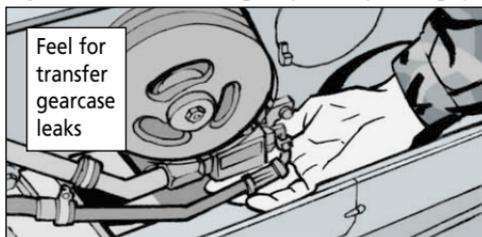
**W**hile you're doing PMCS on your M113-series vehicle, take a quick look at the transfer gearcase for leaks.

It seems that some new gearcase seals aren't getting any sealant when they're first installed. It doesn't take long for those gearcases to leak, so pretty soon you're paying for a new gearcase.

So be alert for leaks. If you spot one, let your DS know right away. And make sure they add a bead of sealant, NSN 8030-00-291-1789, around the outside circumference of the seal's metal frame where it touches the gearcase housing.
