# LAP BELT SLINGING

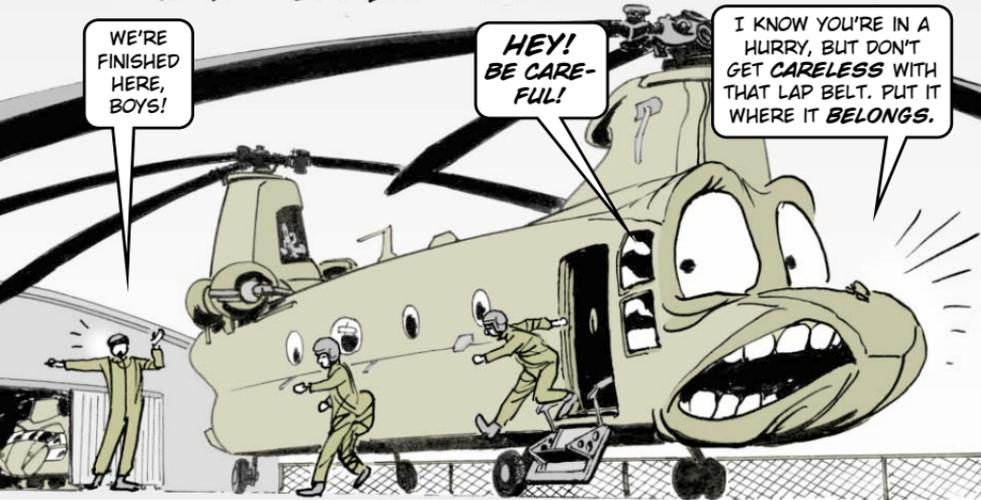
**P**ilots and co-pilots, slow down! Unlatching and slinging lap belts to exit your Chinook puts components of the lower console in harm's way.

When you toss the belts, the buckle smacks the AN/ARC-201 radio and other component knobs, buttons and switches on the intercommunications control system (ICS) boxes, the KY-58, and the AN/ARC-186 radio.

If the lap belt buckle hits the AN/ARC-201 radio, for instance, it'll crack or scratch the liquid crystal display (LCD). That turns the LCD white, distorts the numbers, and makes them unreadable. Then it's NMC.

So take your time to exit the bird. Just unlatch the lap belt and place it on the seat or next to you as you leave.
