# RELIEVE THE PRESSURE

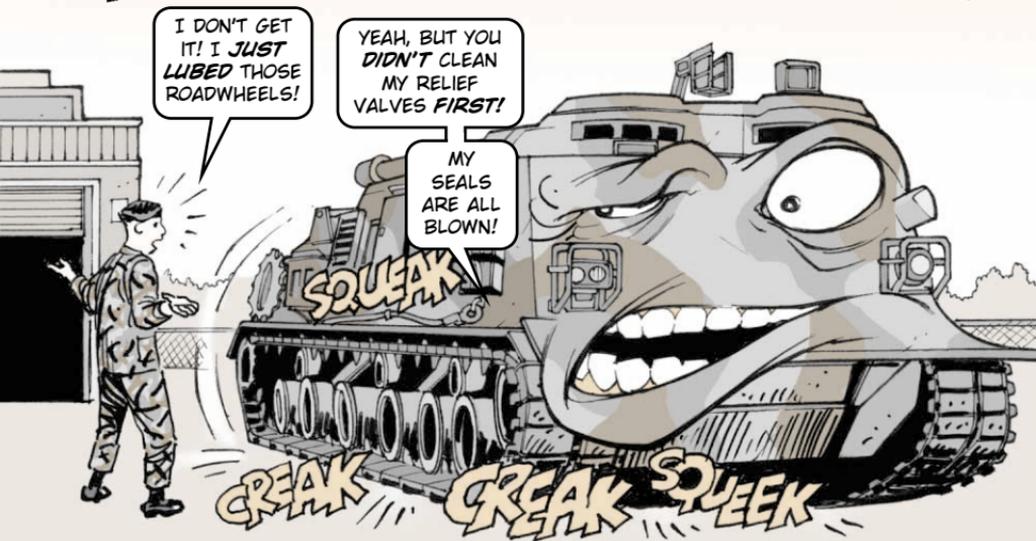
**M**ost people don't work well under a lot of pressure. The same holds true for the roadwheels on your M88A1 recovery vehicle, crewmen.

A roadwheel relief valve that's clogged with crud won't relieve pressure when you pump in new grease. The pressure grows until something gives—usually the hub seal.

When the seal goes, so does the lube. The result is burned-out bearings.

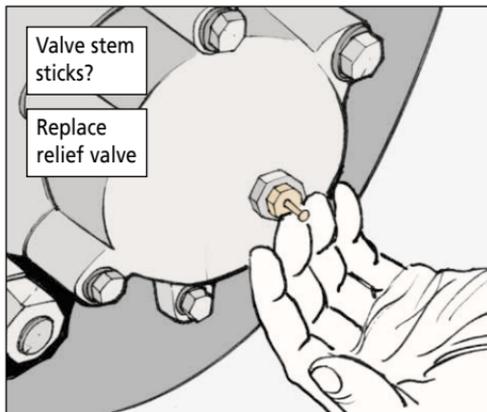
So before adding new grease, use a cloth to wipe away any dirt and mud from the relief valve. Then pull out on the valve stem.

If it slides out smoothly and pops back in when you release it, the valve's OK. If it doesn't, replace it with relief valve, NSN 4820-01-070-7670.
