STEERING SYSTEM LUBRICATION

EARLY RESULTS FROM THE FIRST 5-YEAR SERVICES PERFORMED ON UPPER AND LOWER STEERING PLATE BEARINGS AND LOWER SUSPENSION BEARINGS ON M1000 SEMITRAILERS ARE NOW IN...

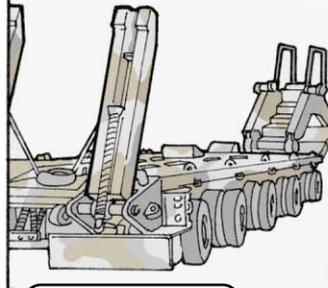
REPORTS SHOW THE LACK OF LUBRICATION **DAMAGES** PINS AND BUSHINGS USED IN THE STRUTS AND STEERING CYLINDERS **SO BADLY...**

...THAT DISASSEMBLY FOR THE SERVICE IS EXTREMELY **DIFFICULT** AND **TIME-CONSUMING.**

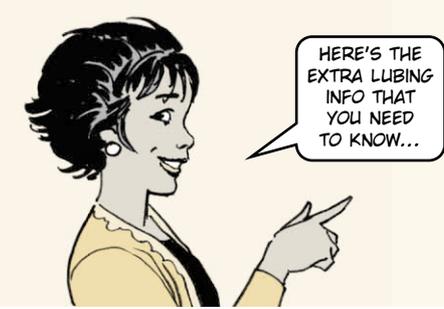
Help out yourself and your unit by doing the lube job right, starting now. Chapter 3 of TM 9-2330-381-14 has the mandatory lube instructions for the M1000. Eyeball Page 3-11, Step 13, for the platform grease fittings vital to the pins and bushings. These fittings are lubed monthly **under normal conditions.**

HERE'S THE EXTRA LUBING INFO THAT YOU NEED TO KNOW...

- ⊛ Lubricate more often during constant use and **twice as often** in extreme dust and sand conditions.
- ⊛ Clean the grease fittings with dry cleaning solvent and dry them off before using the grease gun.

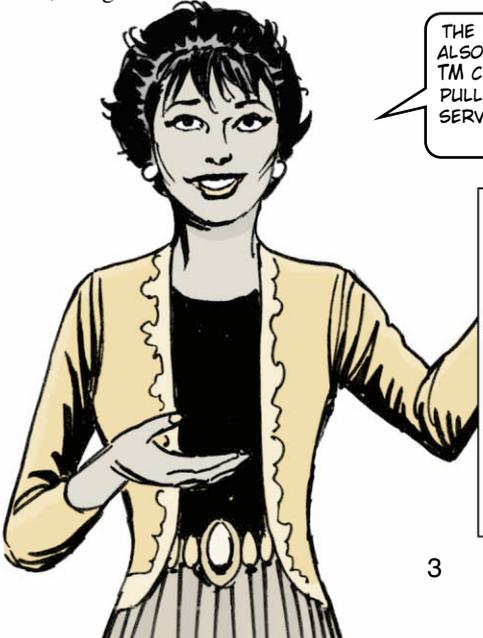
The reports also note grease fittings that won't take grease because the bolt that holds the pins and bushings in place has worked loose.

Seems the pins separate from the bushings, which causes the pins and bushings to rub. Soon the grease holes don't line up right and grease can't get where it needs to be. A loose bolt can also cause the seal to malfunction, letting in dirt and dust.

A new bolt is available that will solve this problem. Make notes in TM 9-2330-381-24P and put these new bolts to work now:

NSN 5306-01-472-3328, which is Item 4, Fig 29; Item 6 in Fig 30; and Item 6 in Fig 32.

Part number SW32291-3, which is Item 19, Fig 30. Order it on DD Form 1348-6, using CAGE 98255 with RIC AKZ.

UNTIL THEY DO, ADD THIS NOTE TO STEP 1 IN PARA 3-2 ON PAGE 3-1 IN THE -14 TM...

TM 9-2330-381-14
 Page 3-1, para 3-2, step 1:

If a lubrication fitting will not accept grease, check to make sure that everything is properly tightened. If loose, tighten appropriate parts. If the lubrication fitting still will not accept grease, notify your supervisor.
