REPLACE LEAKY SEAL

A leaky seal on the Paladin's cupola cover means more than a wet crew, mechanics.

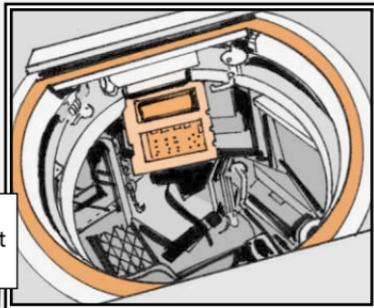
If you don't install the seal correctly, it also lets water drip directly onto the display unit (DU), NSN 7025-01-307-5519. When the DU shorts out, you have to replace it to the tune of more than \$31,000!

Leaky seal drips straight onto DU

1. Remove and discard the old cover seal.
2. Scrape away any dirt or old adhesive from the cover seal groove. Make sure you get it all. If any is left, the new seal may leak.
3. Apply adhesive, NSN 8040-00-152-0063, to a new cover seal, NSN 5330-01-453-1007, and press the seal into the groove.
