Cylinder Rod's *Not* a Step

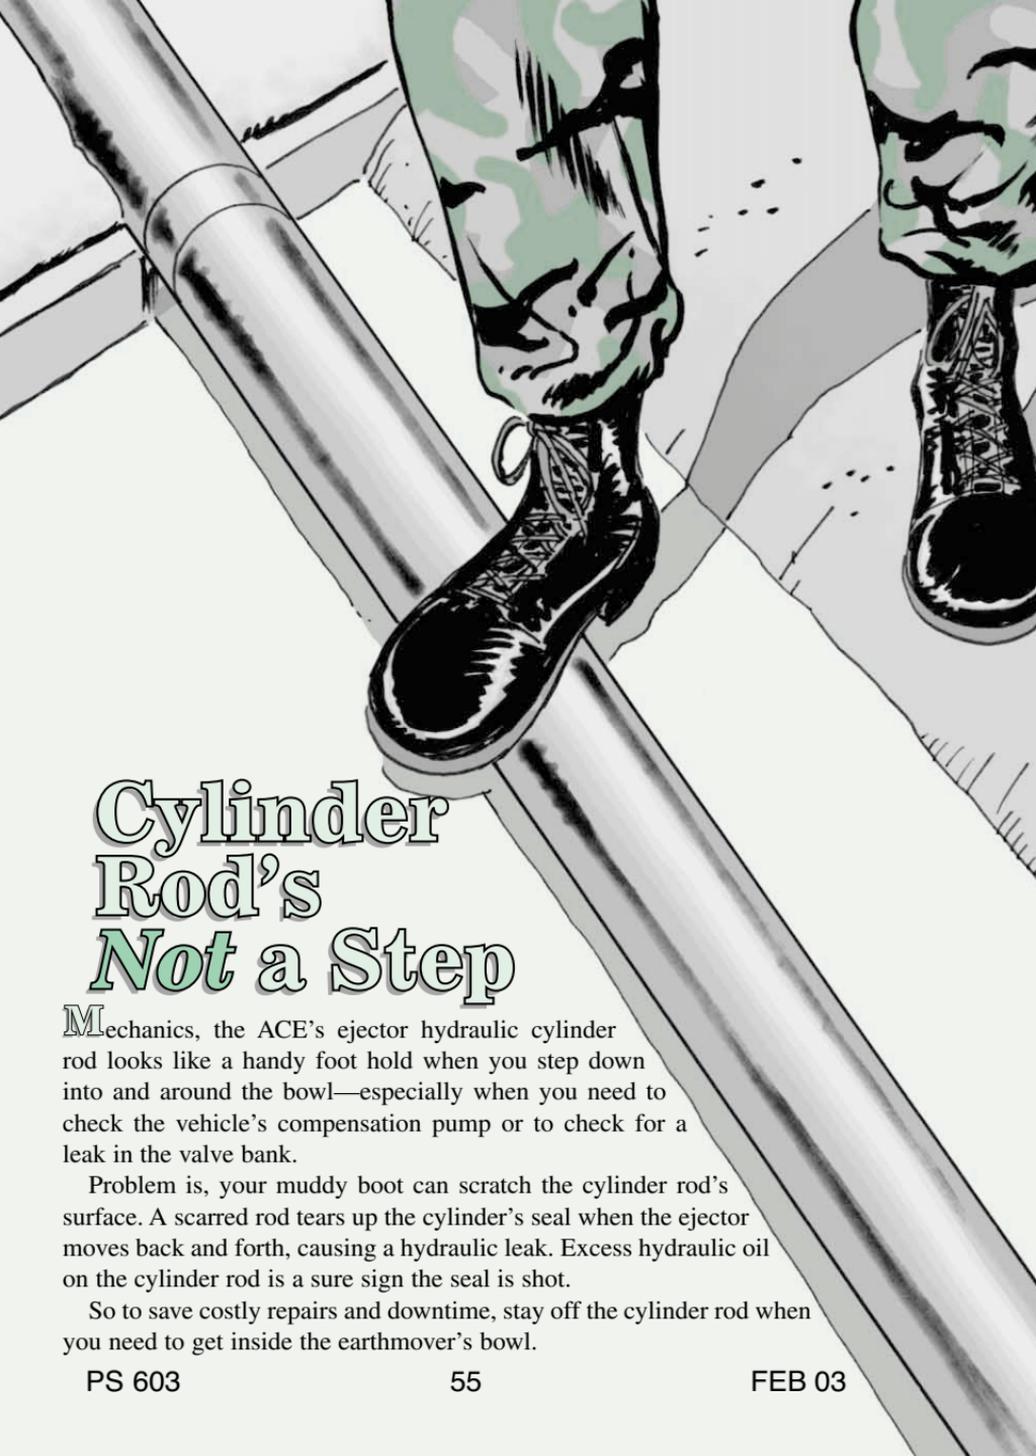
Mechanics, the ACE's ejector hydraulic cylinder rod looks like a handy foot hold when you step down into and around the bowl—especially when you need to check the vehicle's compensation pump or to check for a leak in the valve bank.

Problem is, your muddy boot can scratch the cylinder rod's surface. A scarred rod tears up the cylinder's seal when the ejector moves back and forth, causing a hydraulic leak. Excess hydraulic oil on the cylinder rod is a sure sign the seal is shot.

So to save costly repairs and downtime, stay off the cylinder rod when you need to get inside the earthmover's bowl.
