# SEAL OF DISAPPROVAL

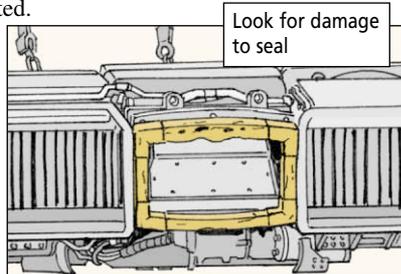
A small leak from your tank's exhaust grille door seal can do a lot of damage. A torn, crushed or brittle seal lets hot exhaust cook the engine and transmission oil coolers and oil cooler crossover hose.

Some tanks use seal, NSN 5330-01-099-6331, that's held in place with 18 screws, NSN 5306-01-309-7031. Other tanks take seal, NSN 5330-01-320-3692, that's mounted with six screws, NSN 5305-00-988-7794. Check the old seal to make sure you order the right replacement.

If you spot a bad seal, replace it using new mounting screws. Those old screws have been through a lot of heat and will snap if you try to reuse 'em.

Coat the threads of the new screws with antiseize compound, NSN 8030-00-597-5367. Then torque 'em to 120-130 lb-in. They'll come out much easier next time.

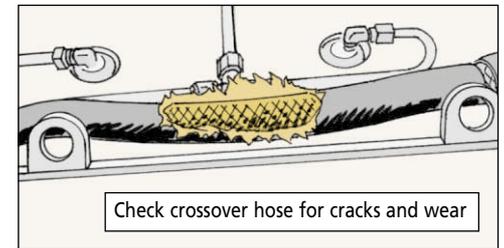
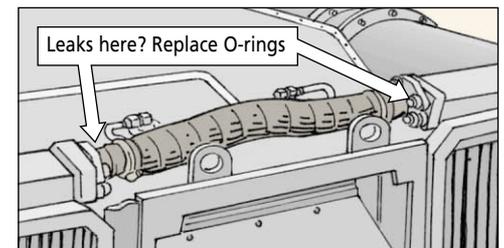
Next, scan the oil cooler crossover hose for cracks and wear. If the hose is damaged, replace it with NSN 4720-01-067-9039.

Secure the hose so it doesn't touch the exhaust duct or the top deck. If the hose touches, it'll burn, so loosen the mounting bolts and reposition it. Torque the bolts to 46-68 lb-ft.

Start the engine and check where the hose clamps to the oil coolers. If you see any leakage, the O-rings could be bad. Replace 'em with NSN 5331-00-165-1944.
