Brush-Guard-Hole Holdup

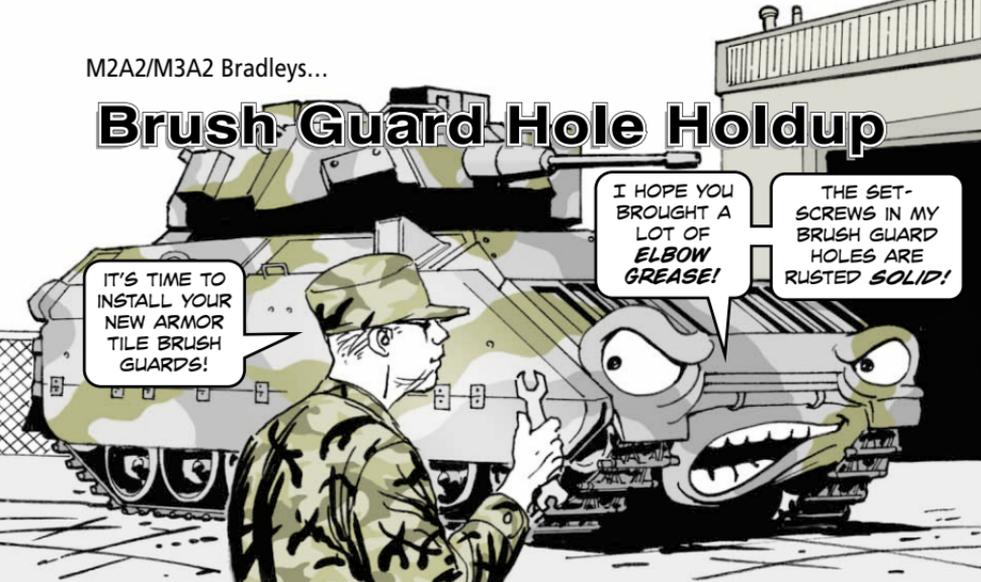
Installing the armor tile brush guards on an M2A2/M3A2 Bradley doesn't seem like a hard job, mechanics. After all, the threaded holes were pre-drilled in the Bradley's skirts during production.

Problem is, those holes weren't protected very well after being drilled. Plastic plugs inserted to keep the threads from corroding didn't work.

Replacing the inserts with setscrews didn't work either. The corrosion problem continued.

Now you face the difficult task of peeling out the plastic inserts or drilling out stuck setscrews.

Don't put it off, though. The longer the inserts and setscrews stay in place, the worse corrosion gets.

Once they're out, replace each insert and setscrew with a bolt, NSN 5305-00-724-7219, and lockwasher, NSN 5310-00-820-6653. Apply some antiseize compound, NSN 8030-00-597-5367, to the threads before installing the bolt. That puts a stop to the corrosion and makes removal a little easier.
