MOVE TABLE TO STOP HARNESS DAMAGE

THE M1068 COMMAND POST CARRIER'S WORKSTATION TABLE DAMAGES THE WIRING HARNESS ON THE TENT INTERFACE PANEL WHEN THE TABLE'S IN THE DOWN POSITION.

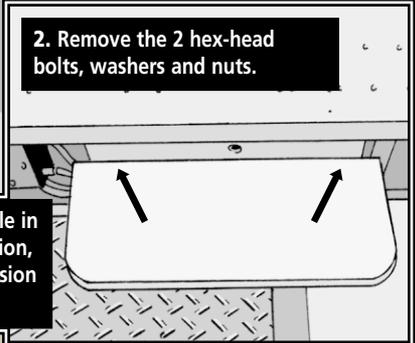
3. Remove the table from the workstation.

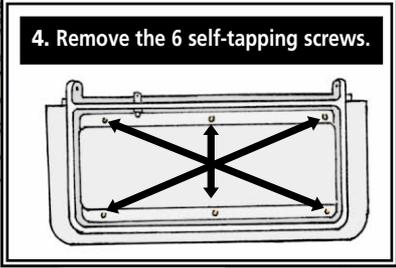
5. Move the table top 1 inch to the right on the mounting bracket.

The table should be flush with the mounting bracket.

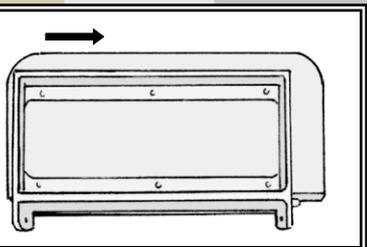
6. Mark and tap the new location for the 6 self-tapping screws.

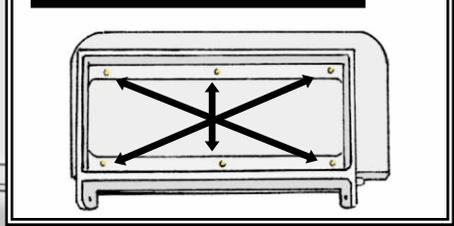
7. Secure the table to the mounting bracket.

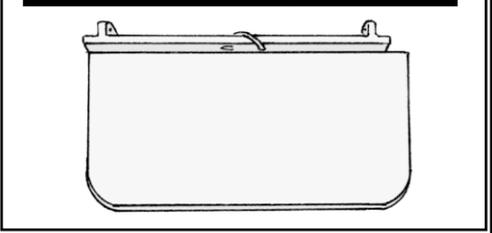
8. Re-mount the table to the workstation.

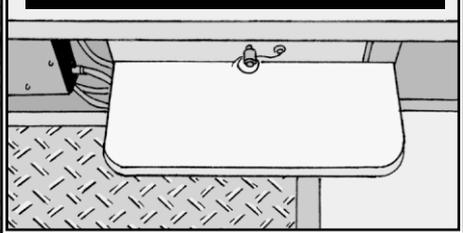
9. Install the 2 hex-head bolts, washers, nuts and tension spring.
