# STOW THE PIN!

# Get the Sand

# Out..Now!

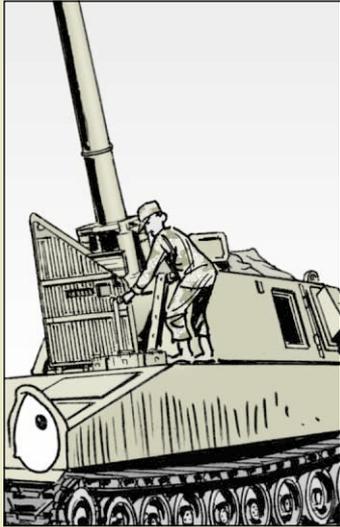
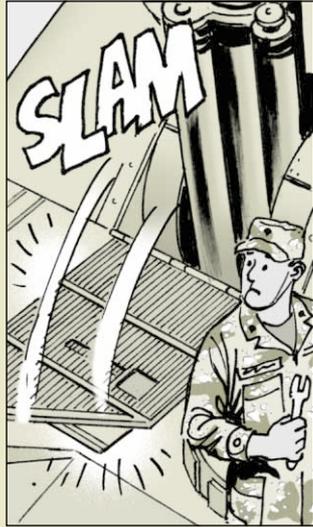
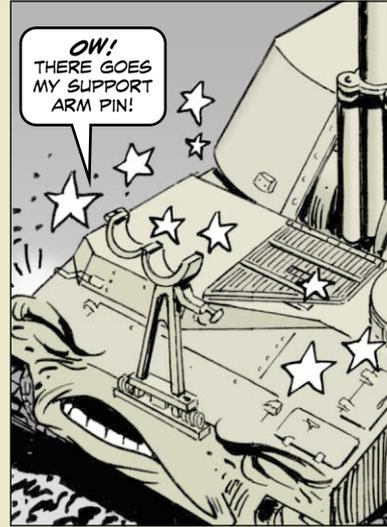
Crewmen, when closing the engine access grille on your howitzer or ammo carrier, make sure you stow the grille support arm's quick-release pin first.

If the pin, NSN 5315-00-419-0758, and chain hang free, they get broken or crushed when the grille is closed. The next time you open the grille, the support arm won't be able to safely hold it up.

The M109A6 Paladin and M992A2 now have an updated kit, NSN 2590-01-470-3665, that beefs up the sleeve that supports the grille in the open position. It includes a new pin that's increased in diameter from 0.25 to 0.375 inch. If your vehicle is equipped with the new kit, order a replacement pin with NSN 5315-00-878-5269.

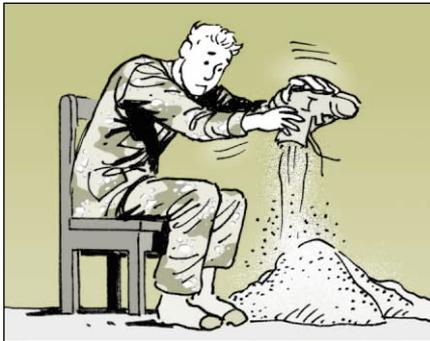
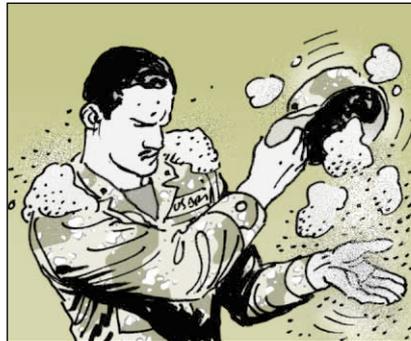
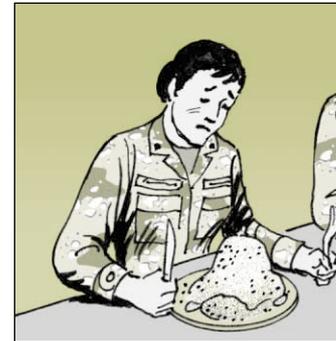
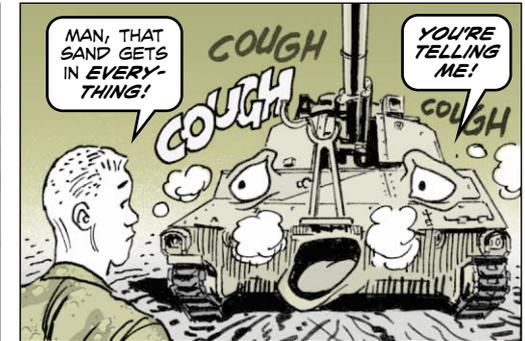
If you spent any time at all in Southwest Asia, you know that sand gets into everything. It gets into your hair, your clothes, even your food.

If your M109A6 saw action there, chances are your hydraulics fared no better. And that means you're probably facing an elevation cylinder failure.

As a precaution, have your mechanic drain the hydraulic fluid and change the filters. Instructions start on Page 18-3 of TM 9-2350-314-20-2-2.

Before he starts, though, make sure the cannon tube is elevated and depressed several times, the cab is traversed 360 degrees, and the rammer activated. That gets any settled sand flowing so that it can be drained along with the hydraulic fluid.
