# Fan Pulley Bearing

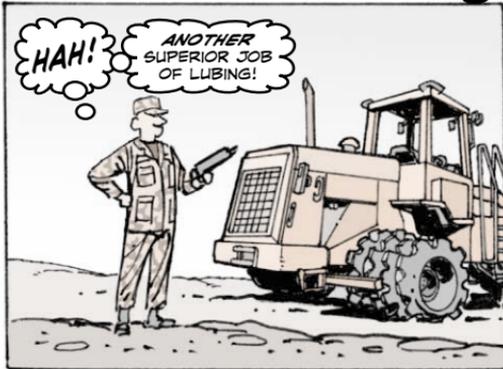
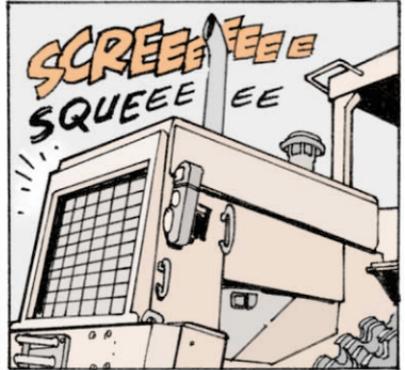
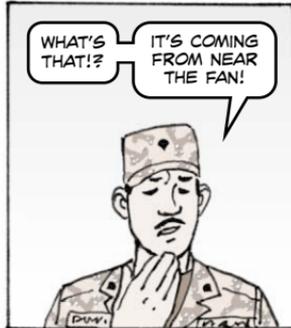
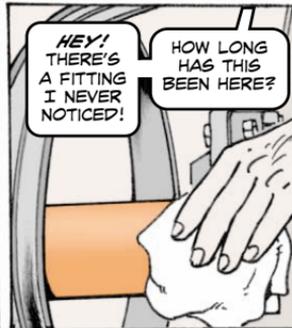
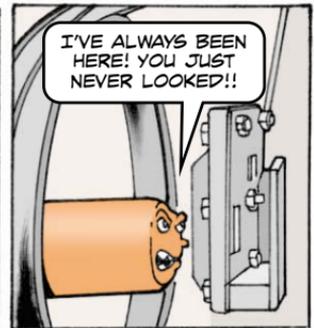
The fan pulley bearing is snubbed often because it's out of sight or covered with mud.

The grease fitting for the fan pulley bearing is hidden behind the fan blades. That means it's hard to find, even after you've opened the engine access door (curbside) and looked inside.

Without lube, the fan pulley's bearing will seize up. Then the blade stops turning freely, letting the engine and transmission overheat.

Keep the fan bearing lubed. During scheduled services, give the fitting four or five shots of grease.
