ENGINE COMPARTMENT PM

MECHANICS, A FEW AREAS IN THE ACE'S ENGINE COMPARTMENT NEED YOUR ATTENTION WHEN YOU'RE PULLING MAINTENANCE.

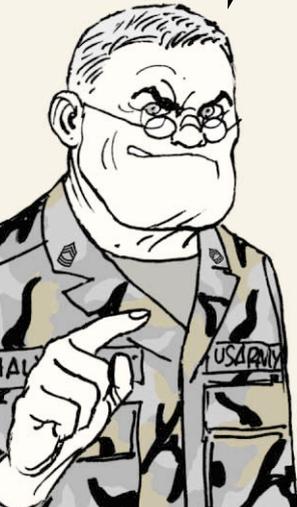
The fan shroud makes a convenient shelf for tools and coffee cups.

No sweat, unless you leave those items sitting there when you close the rear access panels.

Anything left behind bounces off the shelf—then ends up hitting the fan blades after the engine starts and the vehicle starts moving. A fan with broken blades will cause the engine and transmission to overheat.

Before you hop out of the engine compartment, take a quick look around to make sure nothing gets left behind. It can make the difference between a completed mission and waiting for help to arrive.

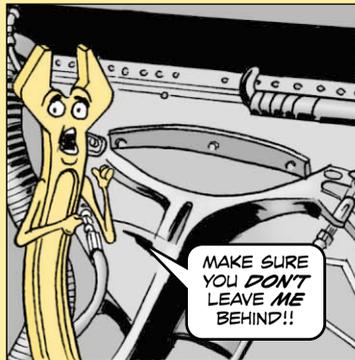
MAKE SURE YOU DON'T LEAVE ME BEHIND!!

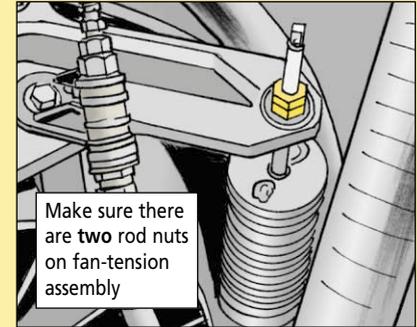
The fan-tension assembly in the vehicle's engine compartment is used to adjust the V-belt tension for the radiator fan.

Vehicle vibration causes the rod nuts on the fan-tension assembly to loosen. The rod's top nut has also been known to get lost during repairs or V-belt adjustment.

Problem is, one nut will work loose, which won't keep the right amount of tension on the belt. That means the V-belt comes loose, causing the engine to overheat—not good, especially in the desert!

Make sure there are **two** rod nuts on fan-tension assembly

So, make sure there are two rod nuts on the fan-tension assembly. If a nut is missing, replace it with NSN 5310-00-732-0559. The nut is shown as Item 4, Fig 130 of TM 5-2350-262-24P.

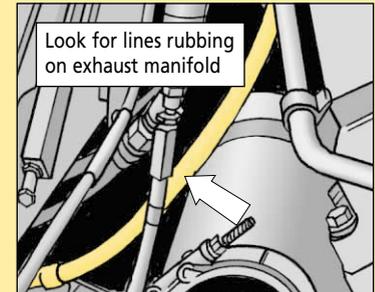
Start the prevention by checking the five hydraulic lines that are mounted directly across from the engine's exhaust manifold.

Each line is held in place by a retaining strap that keeps it snug against the wall.

But straps get misplaced when a hydraulic line is repaired, or when the engine is removed by support. Operating the earthmover when a strap is missing allows those hydraulic hoses to rub up against the engine's exhaust manifold. That can cause a leak and a fire.

Look for lines rubbing on exhaust manifold

Strap keeps hydraulic lines in place

So replace a missing retainer strap with NSN 5340-01-179-7530, or secure the lines with a tie-down strap, NSN 5975-00-570-9598, until the retainer strap is replaced. Straps are shown as Item 40 in Fig 140 of TM 5-2350-262-24P.
