BEAT BATTERY BOX CORROSION

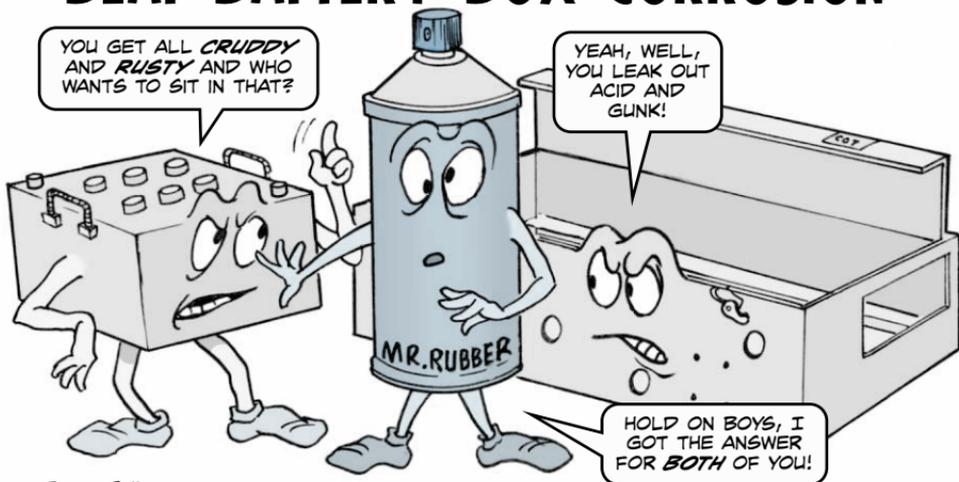
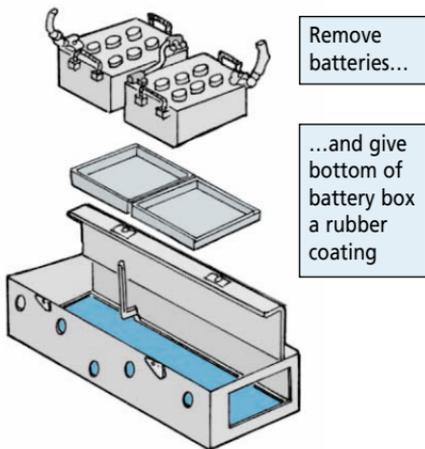
The battery box for the Avenger takes a beating from corrosion. Battery acid leaks onto the bottom of the box and starts industrial strength corrosion. Next thing you know, the box bottom has rusted out and you need a new box.

We stopped the corrosion with spray-on rubber. Remove the batteries and clean off any corrosion or dirt. Then give the bottom of the box a coating of rubber. You can get the spray-on rubber in the hardware section of most discount stores. Wait till the rubber dries and look for uneven areas. Fill them in. You want the coating as even and flat as possible. After the coating completely dries for 24 hours, reinstall the batteries. The rubber will keep the battery acid from reaching the box's metal bottom.
