Too Many Hits

Our Black Hawk unit recently received AN/ARC-220 high frequency radios.

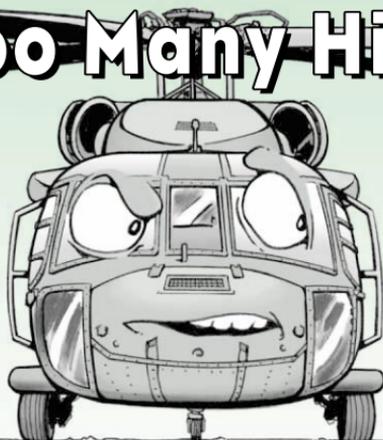
YOUR MISSION'S OVER, BUT YOU **SHOULDN'T** HAVE SLUNG YOUR SEATBELT!

YOU DAMAGED MY AN/ARC-220 LCD PANEL.

SORRY, I FORGOT TO COVER YOUR LCD PANEL.

After a few months, we noticed small cracks and dark blemishes on some of the LCD displays in the center control panel.

This is the result of careless slinging, dropping and flipping of the seat belt to the left after unfastening the buckle.

After too many hits, the LCD panel becomes unreadable. Replacing the ARC-220 high frequency control costs the unit \$5,287, minus the \$2,882 unserviceable credit. We pay a whopping \$2,405 every time the ARC-220 HF radio control head, NSN 5821-01-413-4243, gets damaged.

To protect the LCD panel, otherwise called the optical window instrument, and save maintenance costs, order a LCD panel cover with NSN 6650-01-519-9165. That should cover the problem.

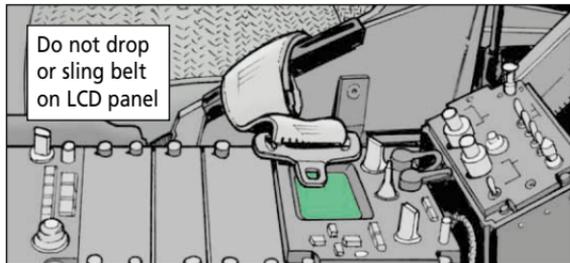
Do not drop or sling belt on LCD panel

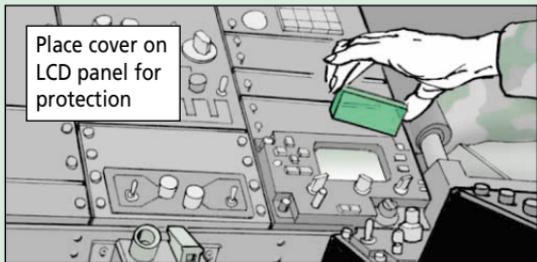
Place cover on LCD panel for protection
