FUEL LINE CRACK

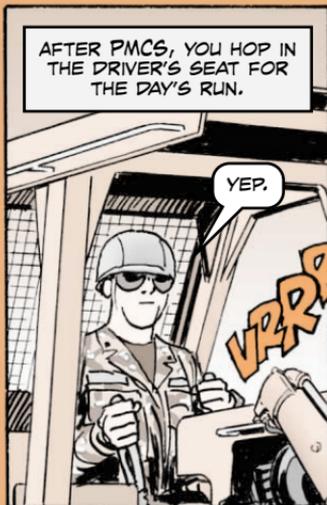
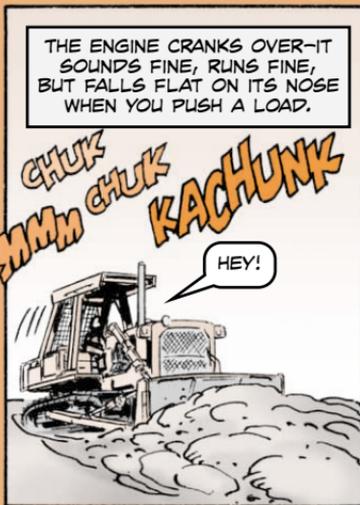
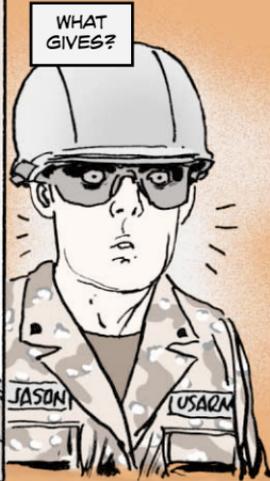
It could be a crack in the air/fuel ratio line that mounts into the air/fuel ratio valve that mounts into the fuel injector pump on the vehicle's curbside. Because of the age of the equipment and vehicle vibration, this line often cracks where it's mounted to the engine block by a small bracket.

The crack is in that part of the line behind the bracket, so you won't see it. The only way you can find the crack is to have your mechanic remove the bracket so he can eyeball the line.

A crack in the line means the engine loses turbo boost pressure that's sent to the air/fuel ratio valve. When this happens, the fuel injector pump can't meter the increased fuel that's needed to push the load.

If your dozer runs fine but shows these symptoms when under a load, have your mechanic come in for a quick look-see. He can replace the line with NSN 4710-01-253-7056. Then your dozer should run like a scalded dog!
