CHECKING VALVES BRINGS RELIEF

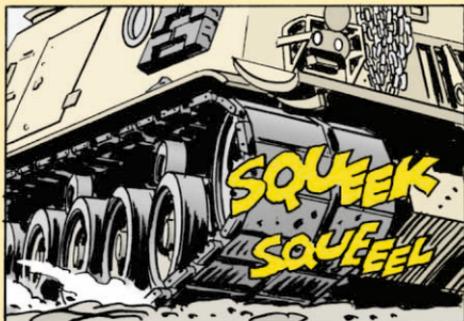
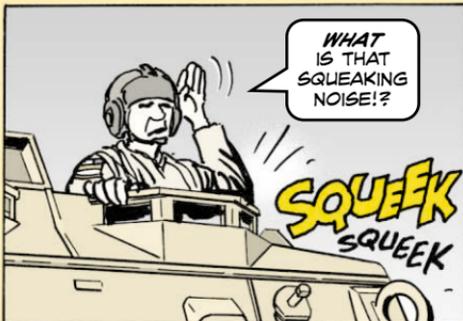
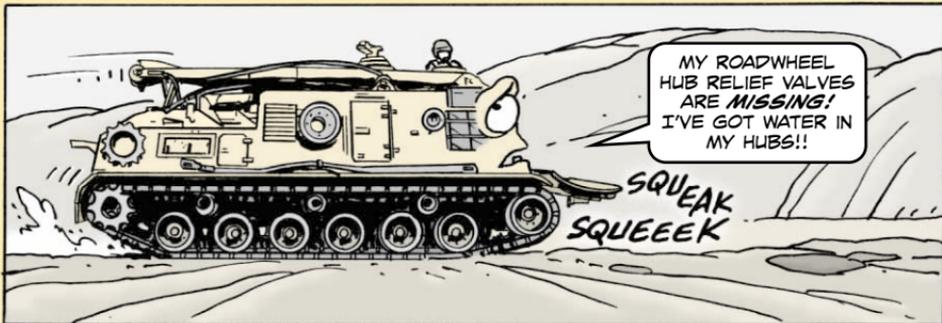
When was the last time you checked the roadwheel hub relief valves on your M88A1 recovery vehicle, mechanics? Take a look now, especially if you've done any recovery work recently.

Vibration can loosen the valves until they fall out. Bushes can snag the relief valve plunger and rip it loose. Either way, water gets inside the road arm spindle where it dilutes the grease and burns up the spindle bearings.

Replace a missing relief valve with NSN 4820-01-070-7670. If the relief valve won't screw in easily, the threads inside the pipe bushing may be damaged. Replace the pipe bushing with NSN 4730-00-187-1413.

If the grease is contaminated, inspect and clean the hub following the instructions starting on Page 8-9 of TM 9-2350-256-20 (Jul 96).
