GUNNER'S WINDOW STRAPS

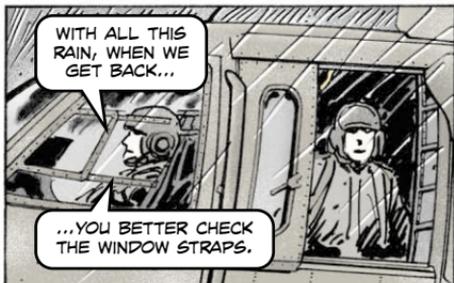
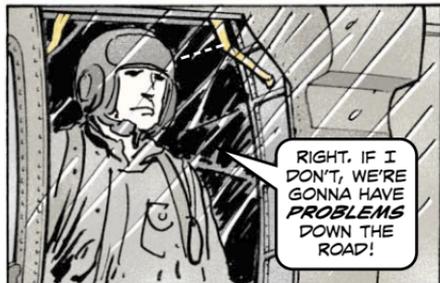
Mechanics, corrosion is a big problem around the front and rear strap attachment areas of the Black Hawk's gunner's window.

Corrosion begins when the cloth strap gets wet and water wicks down to the airframe.

Inspect the front and rear areas for water after flying in wet weather, if the area is wet, dry it up!

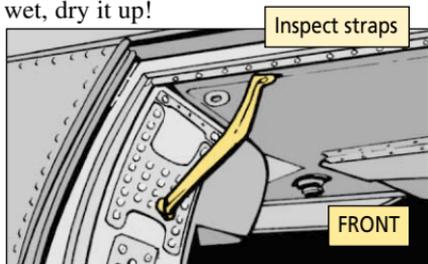
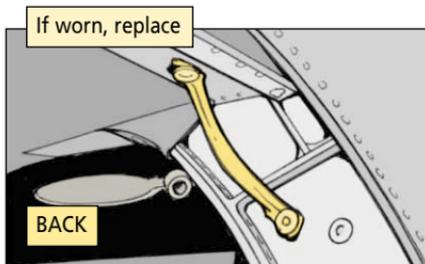
If the strap doesn't have the insulating washer against the airframe, corrosion occurs because of contact with dissimilar metals.

If you remove the strap to replace it, make sure the washer stack-up is correct when installing a new strap.

If you need a little extra protection, put a dab of proseal, NSN 8030-00-616-9191, between the insulating washer and the airframe. That adds extra protection against corrosion near the strap attachment points.
