M1070 HET...

# RUB OUT RUBBING PROBLEM

HMMWVs...

# Improved 3-Point Seatbelt NSNs

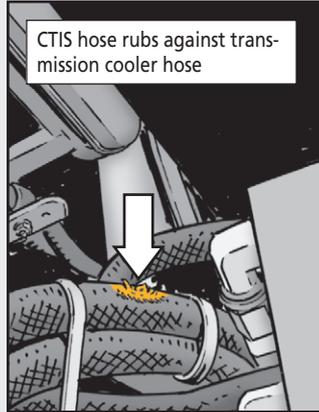
It seems the transmission cooler hoses at the bottom of the radiator are getting rubbed by a CTIS hose just above the No. 1 differential. Enough of that rubbing creates a leak.

CTIS hose rubs against transmission cooler hose

Once a worn hose is replaced, I have my mechanics turn the elbow, NSN 4730-00-231-3014, on the front differential air manifold up a bit. That raises the CTIS hose enough to keep it from rubbing the new cooler line.

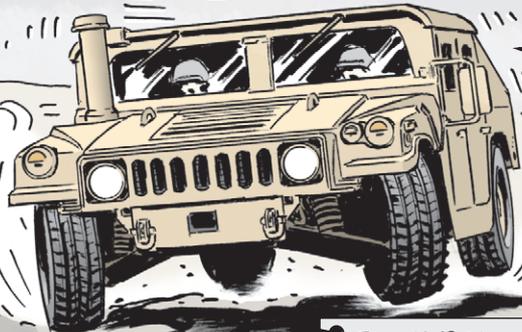
THIS 3-POINT SEATBELT WORKS GREAT!

Use NSN 2540-01-495-0817 to get the 3-point seatbelt assembly for your HMMWV. The belt is made of slicker material for better retraction.
