AH-64D...

COVER THOSE HOLES!

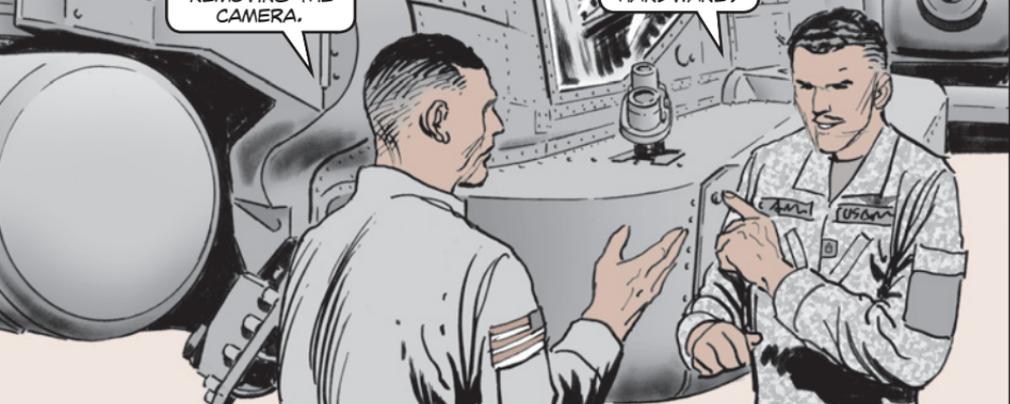
Mechanics, when you remove the universal tracking device (UTD) camera, NSN 6210-01-348-8252, from the AH-64D left extended forward avionics bay (EFAB) and put it back into the vibration analysis kit, NSN 6625-01-282-3746, **don't** leave the four holes in the left EFAB cowling uncovered.

If the four holes are not covered and the bird sits outside in rainy weather, that's not good. Rain leaks through the holes where the UTD camera sits and into the open vent on top of the target acquisition designation sight (TADS) electronic unit, NSN 1680-01-452-9900.

That water can short out the TADS and make your bird NMC.

When camera is removed, put correct hardware in holes

Make sure hardware does not make contact with TADS electronic unit

Before you park your bird outside, make sure the holes are covered after rotor track and balance. Use hole hardware, NSN 5306-01-328-9219, and not the UTD camera attachment hardware.
