# CABLE CRUSHING CONCERNS

YOUR NEW DRIVER'S VISION ENHANCER CABLE IS HERE!

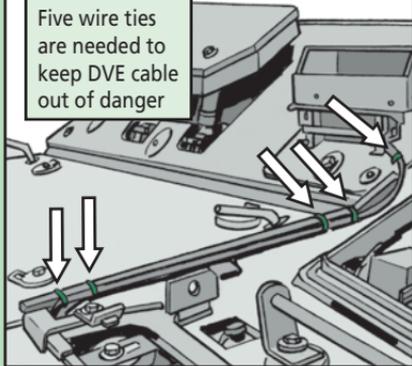
The cable is routed alongside a metal bar that runs between the driver's hatch and the engine access hatch. It's held in place with cable ties.

Problem is, those cable ties can wear out. If that happens, the cable moves around and can get caught in either of the two hatches. **CRUNCH!**

Five wire ties are needed to keep DVE cable out of danger

Check the cable ties periodically for damage. Replace any that are broken or missing with NSN 5975-00-985-6630.

Mechanics, if you have to replace a damaged cable, don't forget to secure the new one with cable ties. Otherwise, you'll soon be replacing the cable again.
