NO ROUGHING THE NUT!

The locking nut on the tripod hub assembly, NSN 5985-01-530-2368, on the next generation receive terminal of the global broadcast service (GBS) receive suite AN/TSR-8 has been getting some rough treatment lately.

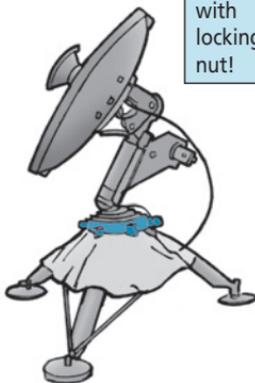
Some of you are rotating the reflector assembly without first loosening the tripod hub locking nut. Some of you are using tools to forcibly tighten the locking nut. Both of these "rough" treatments are damaging or breaking the nut.

Once the nut is broken or significantly damaged, the tripod assembly will not hold the antenna dish upright and locked on the satellite. This is not a good thing!

Take care with locking nut!

So, loosen the nut when you need to rotate the reflector assembly. And use hand power to lock it in place when the reflector is in position.

One more thing: A broken tripod hub assembly will not fix itself. You must turn it in for repair! This is not being done and supply needs are not being met because of it.
