Checks for Better Battery PM

Mechanics, doing PM on the batteries in your M939-series truck is a must! That PM is a lifesaver for the batteries. And since the batteries are in the truck cab, that PM can be a lifesaver for everyone in the truck, too.

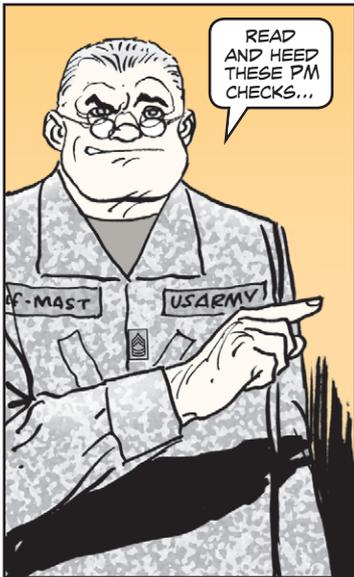
Check the Battery Blocks

Support blocks keep the batteries from bouncing around in the box and getting damaged. The blocks should go under the batteries and snug the batteries up against the retainer.

These blocks are shown as items 26, 27, and 28 in Fig. 153 of TM 9-2320-272-24P. Be sure to inspect these wooden blocks. Battery acid can rot them, and you won't want to use them like that. Replace rotted blocks.

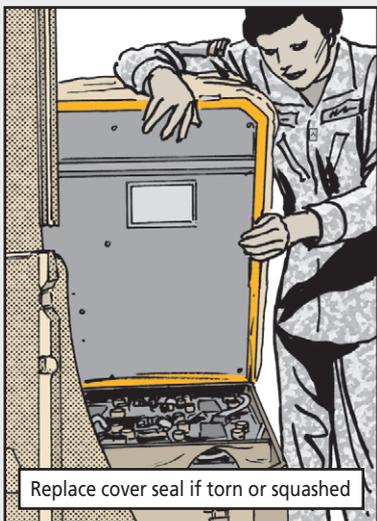
Check for Corrosion

Keep an eye out for corrosion on the batteries and in the battery box. Most of the time, it starts when a battery is overfilled or a filler cap is missing. Electrolyte creeps out and turns into a gray-white powder when it dries.

This corrosion eats cables and brackets and gnaws holes in the box—unless you clean it first. So go after any corrosion you see with a solution of baking soda and water.

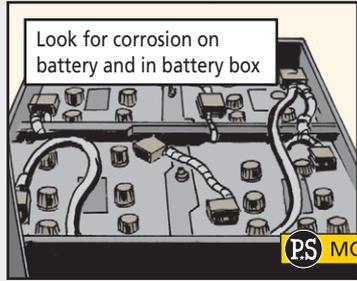
Twice a Year

It's also a good idea to pull the batteries during semiannual services. That's the best way to find some of the hidden rusty spots and pinholes.

Those spots need to be sanded and painted. Holes need patching and patches need painting before the batteries are reinstalled.

Remember to check the vent holes after the box has been painted or patched to make sure they're clear.

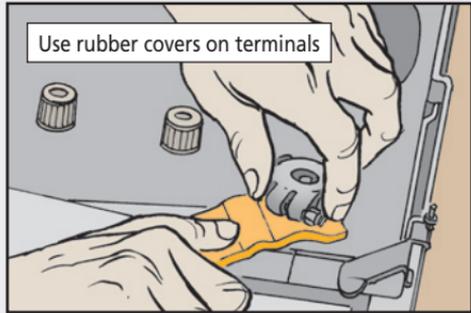
Install a rubber cover, NSN 2530-01-089-4992, on every post with a single cable terminal. Use cover, NSN 5940-00-738-6272, on terminals with one or more cables.

Push the terminal clamps all the way down on the battery posts and tighten them.

Lay the cable flat against the battery before tightening the bolts.

Tighten the bolt and nut using two wrenches of the right size. (Never use an adjustable wrench.) Tighten the nut snug, then give $\frac{1}{4}$ -turn more. Test by pressing and lifting the clamp with your thumb and forefinger. If it moves, tighten another $\frac{1}{4}$ turn and check again.

Give the clamp and post a coat of silicone compound to prevent corrosion. The silicone runs down around the clamp and post to completely seal out moisture. Get a 1-pint can with NSN 8040-01-331-7134 or a 3-oz tube with NSN 8040-01-331-7133.
