M1070P1 HET Tractor...

WAIT! WE'VE GOTTA
MODIFY THE ESCAPE
HATCH FIRST!

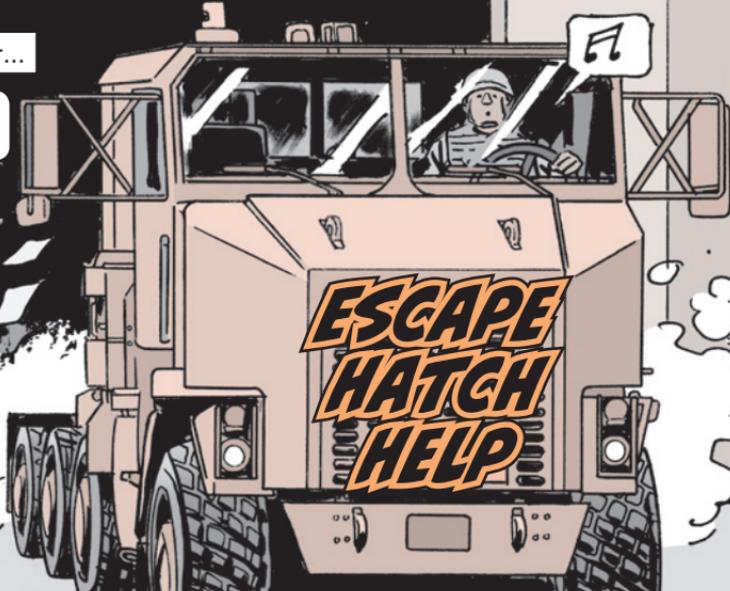
An escape hatch that you can't escape through is a real problem, operators. But if you've got an M1070P1 armored HET, that's exactly what you have.

The rear escape hatch can wedge against the exhaust shield support bracket when you try to open the hatch. That leaves only a partial opening that's not large enough for you to escape through. That means if you're involved in an accident or incident and the escape hatch is the only way out, you could be trapped.

To eliminate the interference with the escape hatch, remove the exhaust shield support and antenna, modify the support and reinstall it to the top of the storage box. Modification requires cutting the existing support, welding a new mounting plate to the cut end and then spot painting the plate.

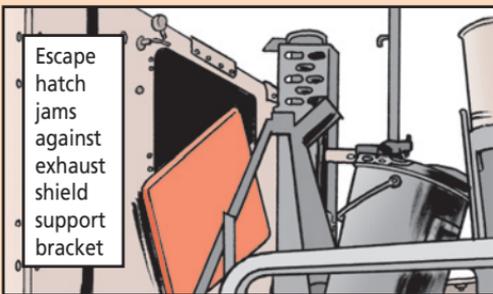
Escape hatch jams against exhaust shield support bracket

You'll find complete instructions on how to modify and move the mount at the AEPS website:
