Keep ECU/PPU on Solid Ground

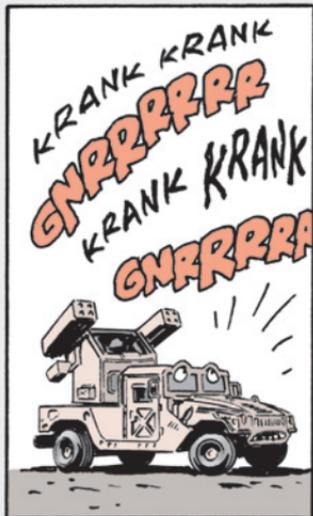
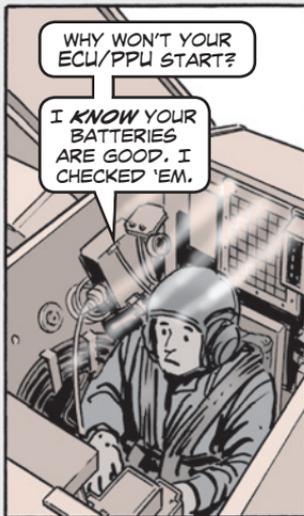
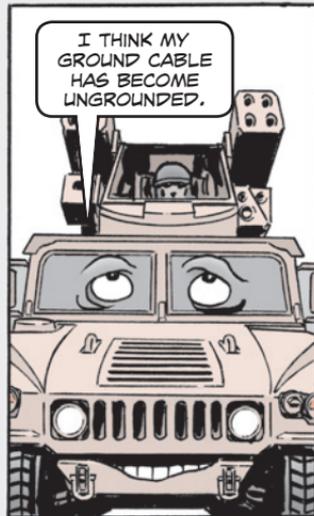
We had trouble with the ground cable connecting the environmental control unit (ECU) and primary power unit (PPU) not making good contact. Corrosion around the connector was the main problem, but there was also arcing at the connection, due to poor contact.

Without a good ground, the ECU/PPU wouldn't start.

We solved the problem with a star washer like the one used with the Avenger antenna. Your commo shop should have plenty of them since they're a common item.

Start by cleaning the stud and ground cable with a wire brush. Put the star washer on the stud first, followed by the ground cable. Then add the normal washer and tighten them together. The star washer helps the ground cable keep a good connection. Of course, it's a good idea to clean off any corrosion monthly.
