# SHOW OLD BLOWER THE DOOR

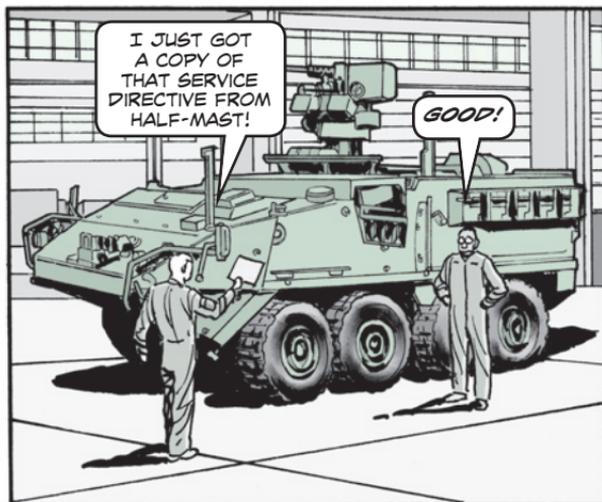
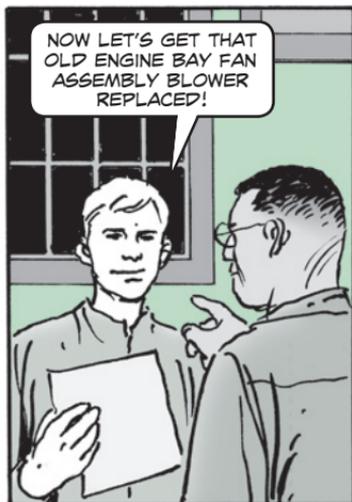
**M**echanics, do any of your Strykers have a Rev G blower, PN 10639516, or a failed blower with any part number in the engine bay fan assembly? If so, then you need to replace it with a new blower, PN 10665115, as soon as possible.

If the engine bay fan assembly in a vehicle fails, is disconnected or removed, or is disabled by pulling circuit breaker #34, then hydrogen gas can accumulate in the battery box. If the concentration gets high enough and there's a spark, it could result in an explosion.

The new blower vents the gas and reduces the chance of an explosion.

Service directive SD-BCT-030, Rev 2, provides the full scoop, including how to turn in removed Rev G blowers. It also includes an interim solution for venting the battery box until a new blower is available.
