MISSING STRAP RAP

One missing strap on the earthmover can cause operations to shut down in flames. Here's a PM tip to prevent those flames.

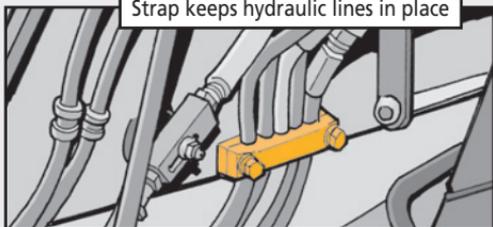
Each line is held in place against the wall by a retaining strap that keeps it snug.

Strap keeps hydraulic lines in place

So have your mechanic replace a missing strap with NSN 5340-01-179-7530, or secure the lines with a tie-down strap, NSN 5975-00-570-9598, until the retainer strap is replaced. Straps are shown as Item 40 in Fig 140 of TM 5-2350-262-24P.

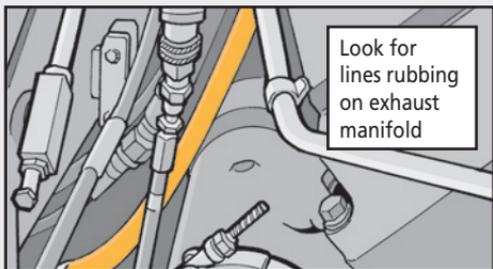
But straps get left off when a hydraulic line is repaired or when the engine is removed by support. It makes no difference how it happens. Operating the earthmover when a strap is missing allows those hydraulic lines to rub up against the engine's exhaust manifold. That can cause a leak—and a fire.

Look for lines rubbing on exhaust manifold
