Drivers, here is one way to avoid a crack-up, vehicle downtime and a big repair bill.

Do **not** back up the 5-tonner with the transfer gear case in low range. If you do, the gear case gets cracked or busted up!

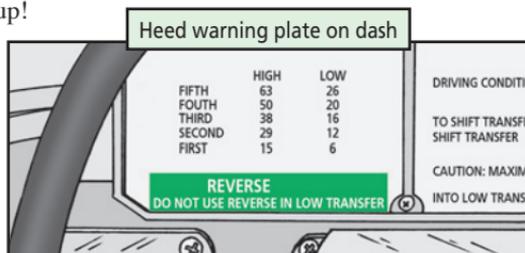
Here's what you get in the kits:

Part	NSN
Bracket assembly	2590-01-473-2719
Ring spacer	5365-01-473-0415
Ring spacer	5365-01-473-0409
Connecting link (M939/A1 kit only)	3040-01-472-7745
Connecting link (M939A2 kit only)	3040-01-472-7747

Part	NSN
Straight pin	5315-00-904-1634
Cotter pin	5315-00-011-9120
Cotter pin	5315-00-012-0123
Plain hex nut (2)	5310-00-891-1733
Straight pin	5315-00-140-1938
Rod end clevis	5340-00-664-7597
Machine bolt (2)	5306-01-123-0891

Units can prevent this costly crack-up by installing a reverse lockout kit that won't let the driver put the transmission into reverse if the transfer is in low range.

For a basic M939-series or M939A1-series vehicle, mechanics install kit, NSN 2520-01-473-2742. M939A2-series vehicles need kit, NSN 2520-01-473-2744.
