OLD VS NEW DRINK TUBES

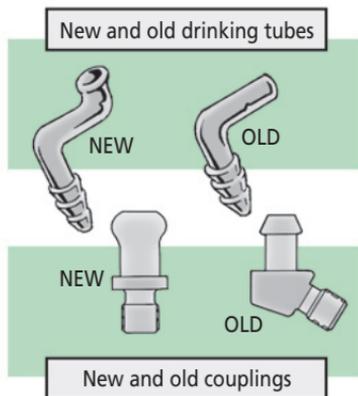
The new drink tube looks like a stretched Z—it has two bends. The old tube has only one bend.

The old coupling has a squared base and points upward toward the front voicemitter and nosecup ridge. The new coupling is straight and points out of the facepiece.

The new drink tube, NSN 4240-01-441-0557, can be used only with the new drink tube coupling, NSN 4240-01-462-0045. If the new tube disappears or the coupling is damaged, no problem. Just replace them like it says in the procedure beginning on Page 2-54 of TM 3-4240-346-20&P.

But if the old drink tube coupling is damaged, your only solution is to turn in the face piece for replacement.

Don't use the new drink tube with the old coupling or visa versa. That puts the drink tube in the wrong position for drinking.
