# A LITTLE LUBE'LL DO IT

In the case of your M88A1 recovery vehicle, that's the steering linkage bell crank assembly.

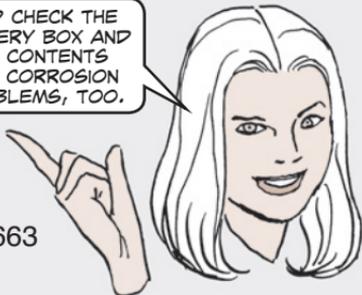
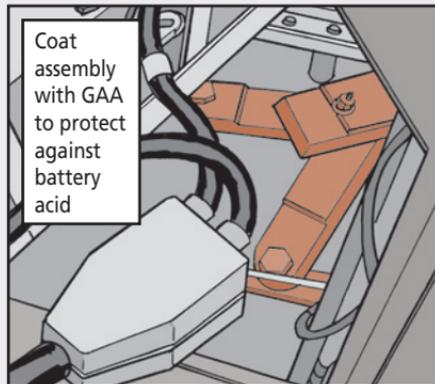
The assembly is to the side and below the battery box, so any battery leakage usually ends up on it, too. If it's not lubed regularly, the resulting corrosion makes the rods brittle. Eventually, they break.

AND CHECK THE BATTERY BOX AND ITS CONTENTS FOR CORROSION PROBLEMS, TOO.

So, before you lube the steering linkage bell crank assembly quarterly with GAA, wipe off any corrosion you find carefully with a rag. If the corrosion is heavy, use a solution of water and baking soda. Wear rubber gloves and safety glasses to protect your hands and eyes.

Next, put a light coat of GAA on the outside of the assembly, then use your grease gun to lube normally. The GAA helps protect the assembly from battery corrosion until it's time to lube again.
