M9 ACE...

MECHANICS, WHERE
THERE'S *SMOKE*,
THERE'S *FIRE!*

KEEP THAT IN MIND WHEN IT COMES
TO THE FIVE HYDRAULIC LINES
MOUNTED DIRECTLY ACROSS FROM
THE ENGINE'S EXHAUST MANIFOLD.

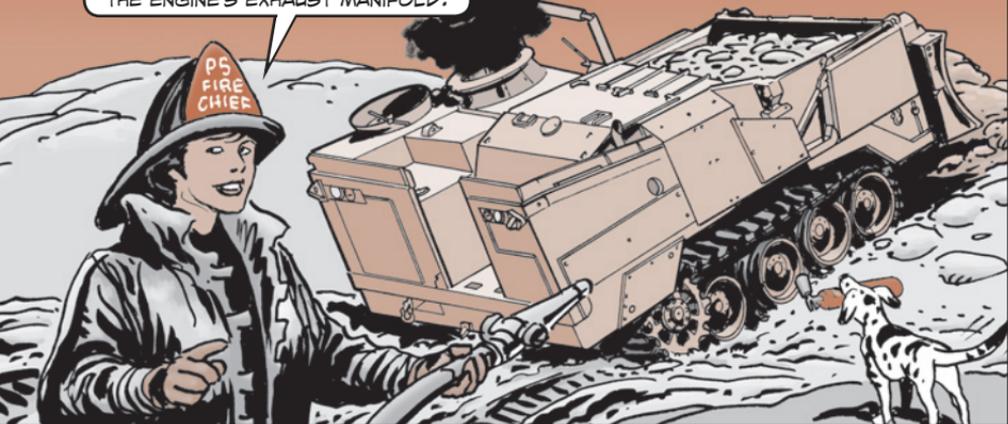
MISPLACED STRAP

The lines are held in place by a retaining strap that keeps them snug against the wall.

Straps get misplaced when a hydraulic line is repaired, or when the engine is removed by support. How it happens makes no difference. An earthmover that's operating with a missing strap means those hydraulic lines will eventually rub up against the engine's exhaust manifold—causing a fire!

Replace a missing retaining strap with NSN 5340-01-179-7530, or secure the lines with a tie-down strap, NSN 5975-00-570-9598, until the retaining strap is replaced. Retaining straps are shown as Item 40 in Fig 140 of TM 5-2350-262-24P.
