M992A2
Ammo
Carrier...

WHAT TO DO WITH THAT EXTRA WIRE

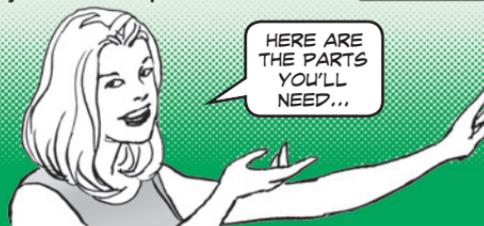
The fire wire in the lower front of the engine compartment of some M992A2 ammo carriers has some extra slack, mechanics. During production, that slack was coiled up in the corner of the engine compartment to keep it from getting cut or damaged.

Problem is, the extra wire was supposed to be formed into a dip at the front of the engine compartment to provide better fire coverage.

So if your carrier has a serial number of 821 or higher, you'll need to secure the extra wire the next time the powerpack is removed. Just gather all the slack in the middle of the engine compartment and clamp the fire wire in place to the existing boss on the carrier's hull. Make sure you don't crimp the wire.

Item	NSN
Rubber bushing	5365-99-881-6505
Loop clamp	5340-00-057-2890
Lock washer	5310-00-045-3296*
Machine screw	5305-00-984-6208*
