Safe Storage for Copperhead Extractor

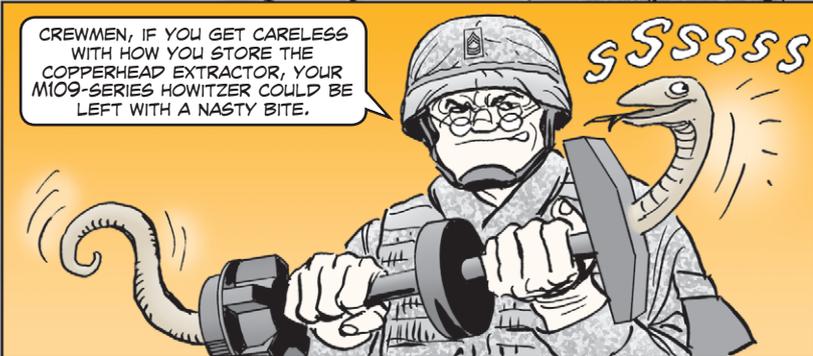
If you store it backwards, or with the brace in the vertical position, the brace bangs into the wiring harness that powers the slip ring contact arms. Banging wears away the harness cover and leads to arcing and electrical failure.

Slide the brace forward on the extractor shaft until it touches the end of the ratchet handle. Turn the drive nut on the shaft end counter-clockwise until the brace is held firmly against the ratchet handle. Then, turn the extractor so that the brace is horizontal and facing away from the rear door when it's stored in the cab rack. That way, you avoid harness damage altogether.

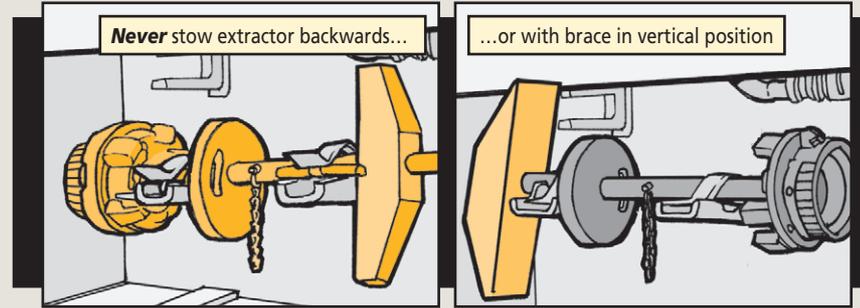
The same problems occur when the brace isn't tightened in place, even if the extractor is stowed properly. Vibration shifts the brace around until it snags the wiring harness.
