The Weakest Link!

Stick a magnet or a knife in your ACU pocket and take a walk to your AN/ASM-189 and -190 electronic vans. The van's tailgate chain may have a weak link and you need to find it!

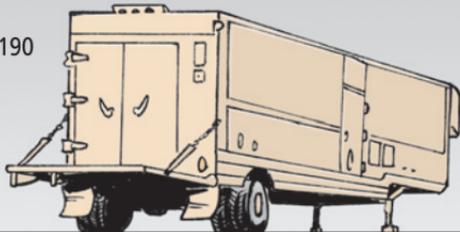
The last link of the chain—the one that joins the chain to the tailgate—might be aluminum. If it is, it just might fail! This could cause a soldier to take a tumble to the ground and be hurt.

See if the magnet is attracted to the link. If it is, the link is steel and you're in good shape. Or you can use the knife and try to make a slight scratch in the link. If it scratches easily, it's aluminum!

A link that is not welded closed is another sure sign of trouble. Check all the links for gaps.

Replace an aluminum link with a steel riveted link, NSN 4010-01-218-6340.

While you're checking this last link, check them all for rust and other signs of weakness. You might want to run that magnet over all the links just in case. Only standard welded links and the steel riveted hammer-lock type that you should use as a replacement link are authorized to be in the tailgate chain.

One other thing: don't shoot yourself in the foot by using tape or other bolts to hold the support chain together. Every link should be steel and strong.
