Keep Cap on Short Leash

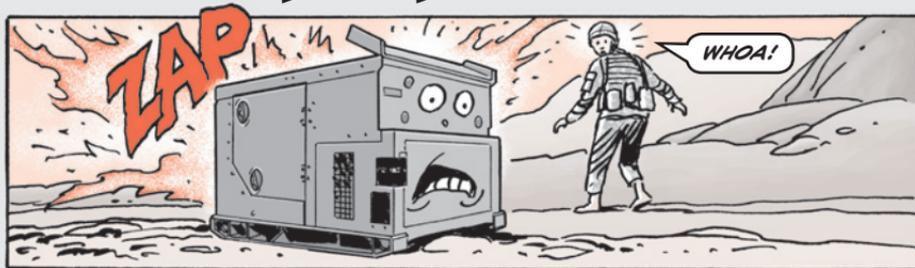
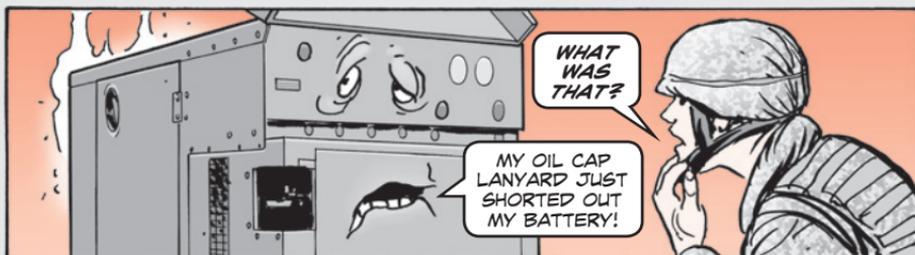
The crankcase oil cap on 5- and 10-KW TQG generators is held in place with a lanyard made of metal chain. The lanyard is there to keep the oil cap from getting lost.

However, on some generators, the lanyard is too long. In those cases, the chain hangs down far enough to contact the battery terminal and cause a short.

The fix is simple. Just take a few links out of the chain to shorten it. Make sure you leave the lanyard long enough to still be able to remove the oil cap.

Editor's note: Looks like you brought that problem up short. Just be careful that you don't shorten the lanyard too much. It can take three or four revolutions to remove the oil cap. That twists up the chain and shortens it even more.

An even better solution is to make sure the battery posts have terminal covers, NSN 5940-00-738-6272, in place. Then install a plastic cover, NSN 6160-01-420-8960, over the entire battery. With all three covers in place, even a long lanyard will be less likely to cause a short.
