Look for the Notch

PERSONNEL WITH THE JOINT ATTACK MUNITION SYSTEMS (JAMS) PROJECT MANAGER'S OFFICE HAVE DISCOVERED A NUMBER OF HELLFIRE LAUNCHER RAILS IN THE FIELD WITH NOTCHES AT THE AFT SHOE LOCATION.

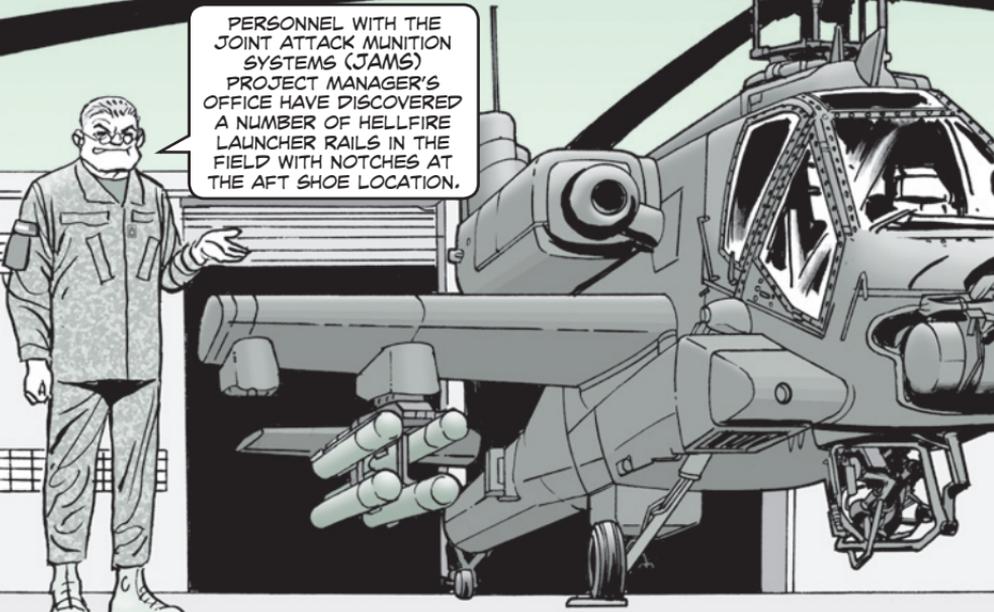
The notch is probably caused by wear from vibration and is usually the length of the aft missile shoe. It's possible the notch could cause a hangfire or loss of missile control after launch.

So Hellfire crews need to immediately check all their launcher rails for notching. Check not only the aft missile shoes area, but the entire rail for notches. If you spot any, replace the rail.

JAMS put out a safety of use message, AMCOM-08-003, on the launcher notching.

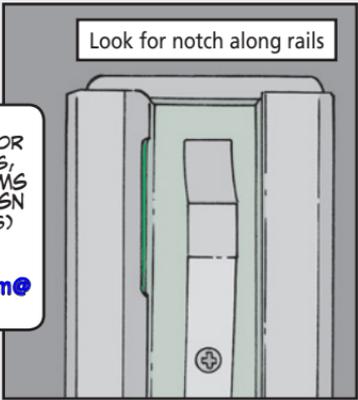
Look for notch along rails
