Brake Warning Light On?

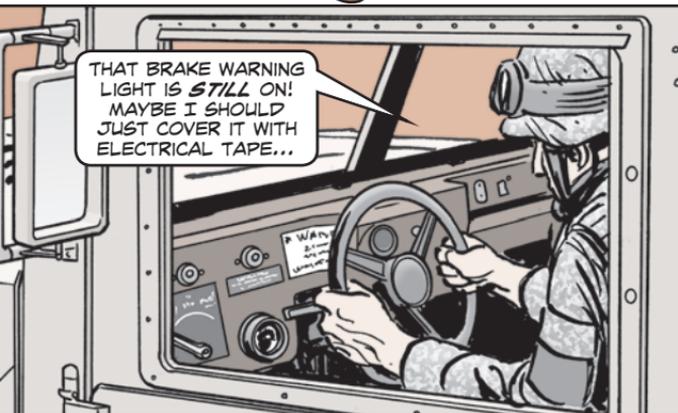
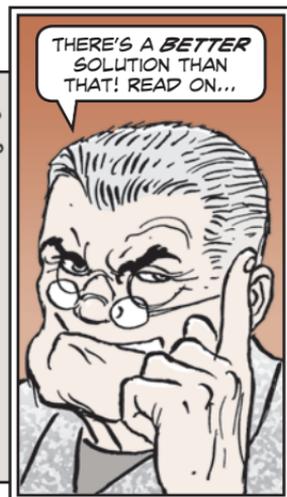
Something is wrong when the brake warning light stays on (no kidding!). But before you replace any parts, make sure you bleed the vehicle's brake lines.

Air trapped in the lines can cause the light. Your time and new parts can be wasted if you don't bleed the brakes first.

If the light stays on after bleeding, use the troubleshooting info starting on Page 2-342 of TM 9-2320-280-20-1 and Page 2-328 of TM 9-2320-387-24-1. If the proportioning valve is the culprit, replace it. Use NSN 4820-01-186-0822 to get the valve for basic HMMWVs.

For A1 and A2 HMMWVs, use proportioning valve, NSN 4820-01-359-9458. The ECV-series HMMWVs come with two proportioning valves. For the valve closest to the master cylinder, use NSN 2530-01-473-2724. For the other valve use NSN 4820-01-359-9458.

Do not try to save a "bad" valve by taking it apart and adjusting it. Any tampering ruins the calibration set at the factory.

When you replace the proportioning valve, add a light coat of lube, NSN 9150-00-273-2389, to the valve's electrical connector pins. A little lube heads off corrosion.
