TM Art Can *Damage* Wrecker's Boom Winch

YOUR M1089A1 FMTV'S UNDERLIFT ASSEMBLY OPERATION IN TM 9-2320-392-10-1 IS AN EXAMPLE.

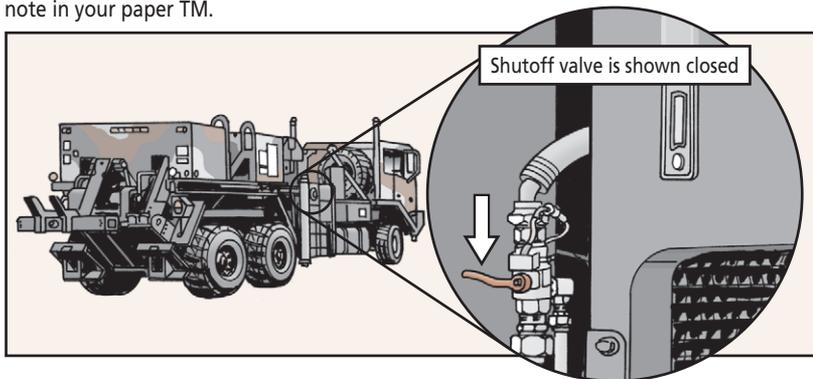
The artwork for the Underlift Assembly Operation in WP 0037 00-01 of TM 9-2320-392-10-1 (Mar 09) and IETM 9-2320-391-10-1/2 (Mar 09) is incorrect. The shutoff valve is shown in the closed position but the callout says the valve is in the open position.

The written instructions for this task correctly state that the valve must be in the open position. However, because the artwork is wrong, some users have mistakenly placed the valve in the closed position, damaging the boom winch.

So disregard the artwork showing the position of the shutoff valve for this procedure. The valve is open when the handle is straight down *in line* with the valve, *not* at a right angle. Make sure the valve is in the open position when performing this task. And make a note in your paper TM.

The valve should only be closed for maintenance purposes. Secure the valve in the open position using a zip tie, such as NSN 5975-01-034-5871. Any zip tie will do, and you should be able to find them in your motor pool.

There is also a kit, PN 57K2035, which disengages the PTO when the valve is in the wrong position. This kit has already been installed on wreckers with serial numbers greater than 113414. If you need this kit, get it through BAE's Veronica Mallard at (281) 616-6354 or email: veronica.mallard@baesystems.com

How does the PTO—or power takeoff—relate to the shutoff valve? The PTO drives a hydraulic pump that pressurizes the hydraulic system to make it work. If the shutoff valve isn't open, too much pressure builds on the hydraulic system when operating. That can lead to blown seals and even blown hydraulic lines, which can render the whole system NMC.

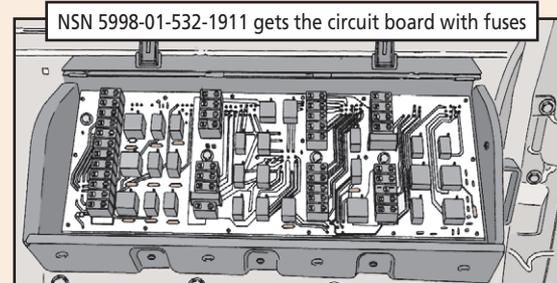
Dear Sergeant R.R.,
You bet. Order the next higher assembly, the power distribution panel's printed circuit board (with fuses), NSN 5998-01-532-1911, if your A1 truck's serial number is within the 11,438 – 99,999 range.

TM 9-2320-365-24&P and TM 9-2320-366-24P are used *only* for FMTV AO trucks with a serial range of 00001 – 11,437. Use IETM 9-2320-391-24&P (EM 0195) dated March 2008, for PMCS, maintenance and ordering repair parts for 2½- and 5-ton A1 trucks. The IETM is a four compact-disk set and each CD needs to be loaded onto a laptop computer or MSD prior to viewing.

FMTV A1 trucks use two serial number ranges based on the configuration of the truck. Earlier A1 trucks equipped with the 3126 CAT engine have a serial range of 11,438 – 99,999. Newer A1 trucks with the C7 CAT engine use a serial number range of 100,001 and above. You'll find these serial numbers on the data plate found on the left side of the steering column.
